**Appendix E Arborist Report – Bear Valley Parkway
Widening Project, Escondido
(December 2016)**

ARBORIST REPORT
Bear Valley Parkway Widening Project, Escondido

DUDEK

DECEMBER 2016

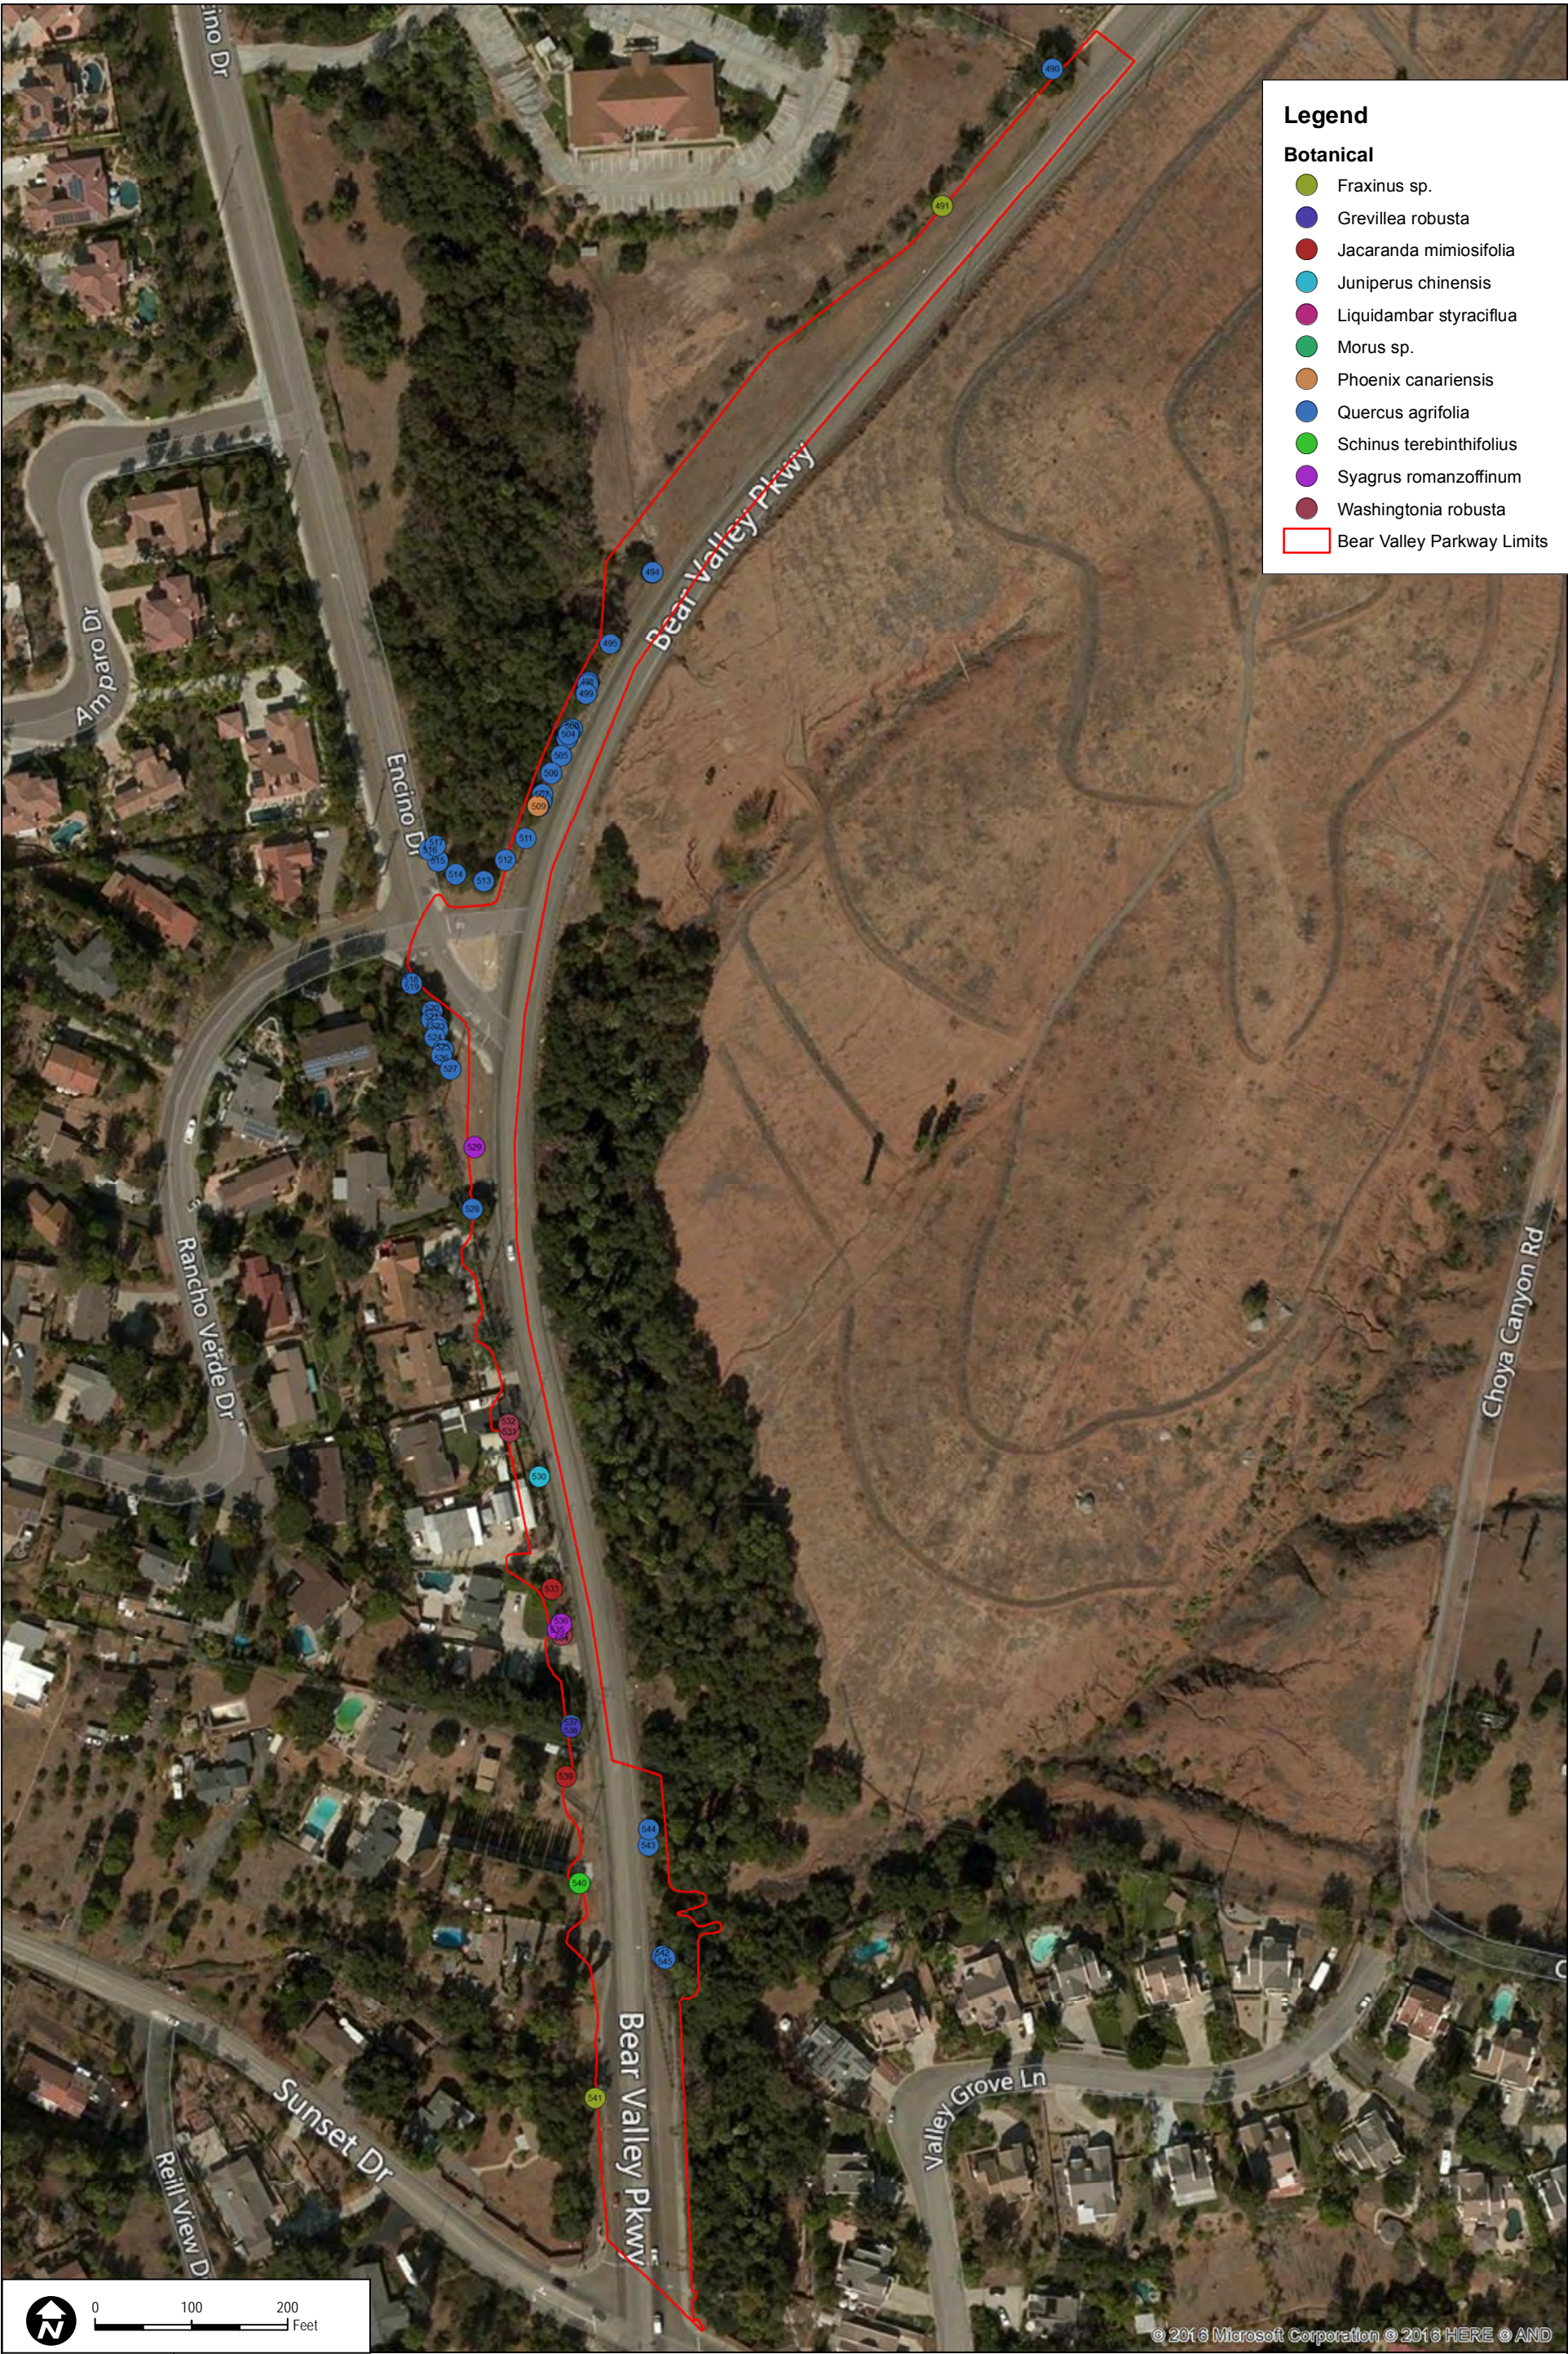
Tree Locations Exhibit

There are 56 trees representing nine individual species located within the project tree survey area that meet the City’s criteria for a “mature” or “protected” tree. As Table 1 indicates, most of the inventoried trees are native to California. Tree species found on site consist primarily of ornamental trees. Ornamental trees found on site include ash (*Fraxinus* sp.), silk oak (*Grevillea robusta*), jacaranda (*Jacaranda mimosifolia*), Chinese juniper (*Juniperus chinensis*), Canary Island date palm (*Phoenix canariensis*), Brazilian pepper (*Schinus terebinthifolius*), Queen palm (*Syagrus romanzoffiana*), and Mexican fan palm (*Washingtonia robusta*). One native tree species, coast live oak (*Quercus agrifolia*), is found on the project site. Table 1 provides a summary of the nine species mapped and evaluated within the tree survey area. The tree location exhibit in Appendix A presents the location of the individual trees mapped and assessed for the project.

Overall, the trees exhibit growth and structural conditions that are typical of their locations as both landscape and natural trees. The trees include various trunk and branch maladies, as well as varying health and structural conditions. As presented in the tree information matrix in Appendix B, most of the individually mapped trees, 82% (46 trees), exhibit fair health condition; 7% (4 trees) are in good health condition; and 11% (6 trees) are in poor health. Dead trees were not evaluated during the tree inventory. Structurally, 7% (4 trees) of the individually mapped trees are considered to exhibit good structure, 64% (36 trees) exhibit fair structure, and 29% (16 trees) exhibit poor structure. Good condition trees exhibit acceptable vigor, healthy foliage, and adequate structure, and lack any major maladies. Fair condition trees are typical, with few maladies but declining vigor. Poor condition trees exhibit declining vigor, unhealthy foliage, poor branch structure, and/or excessive lean.

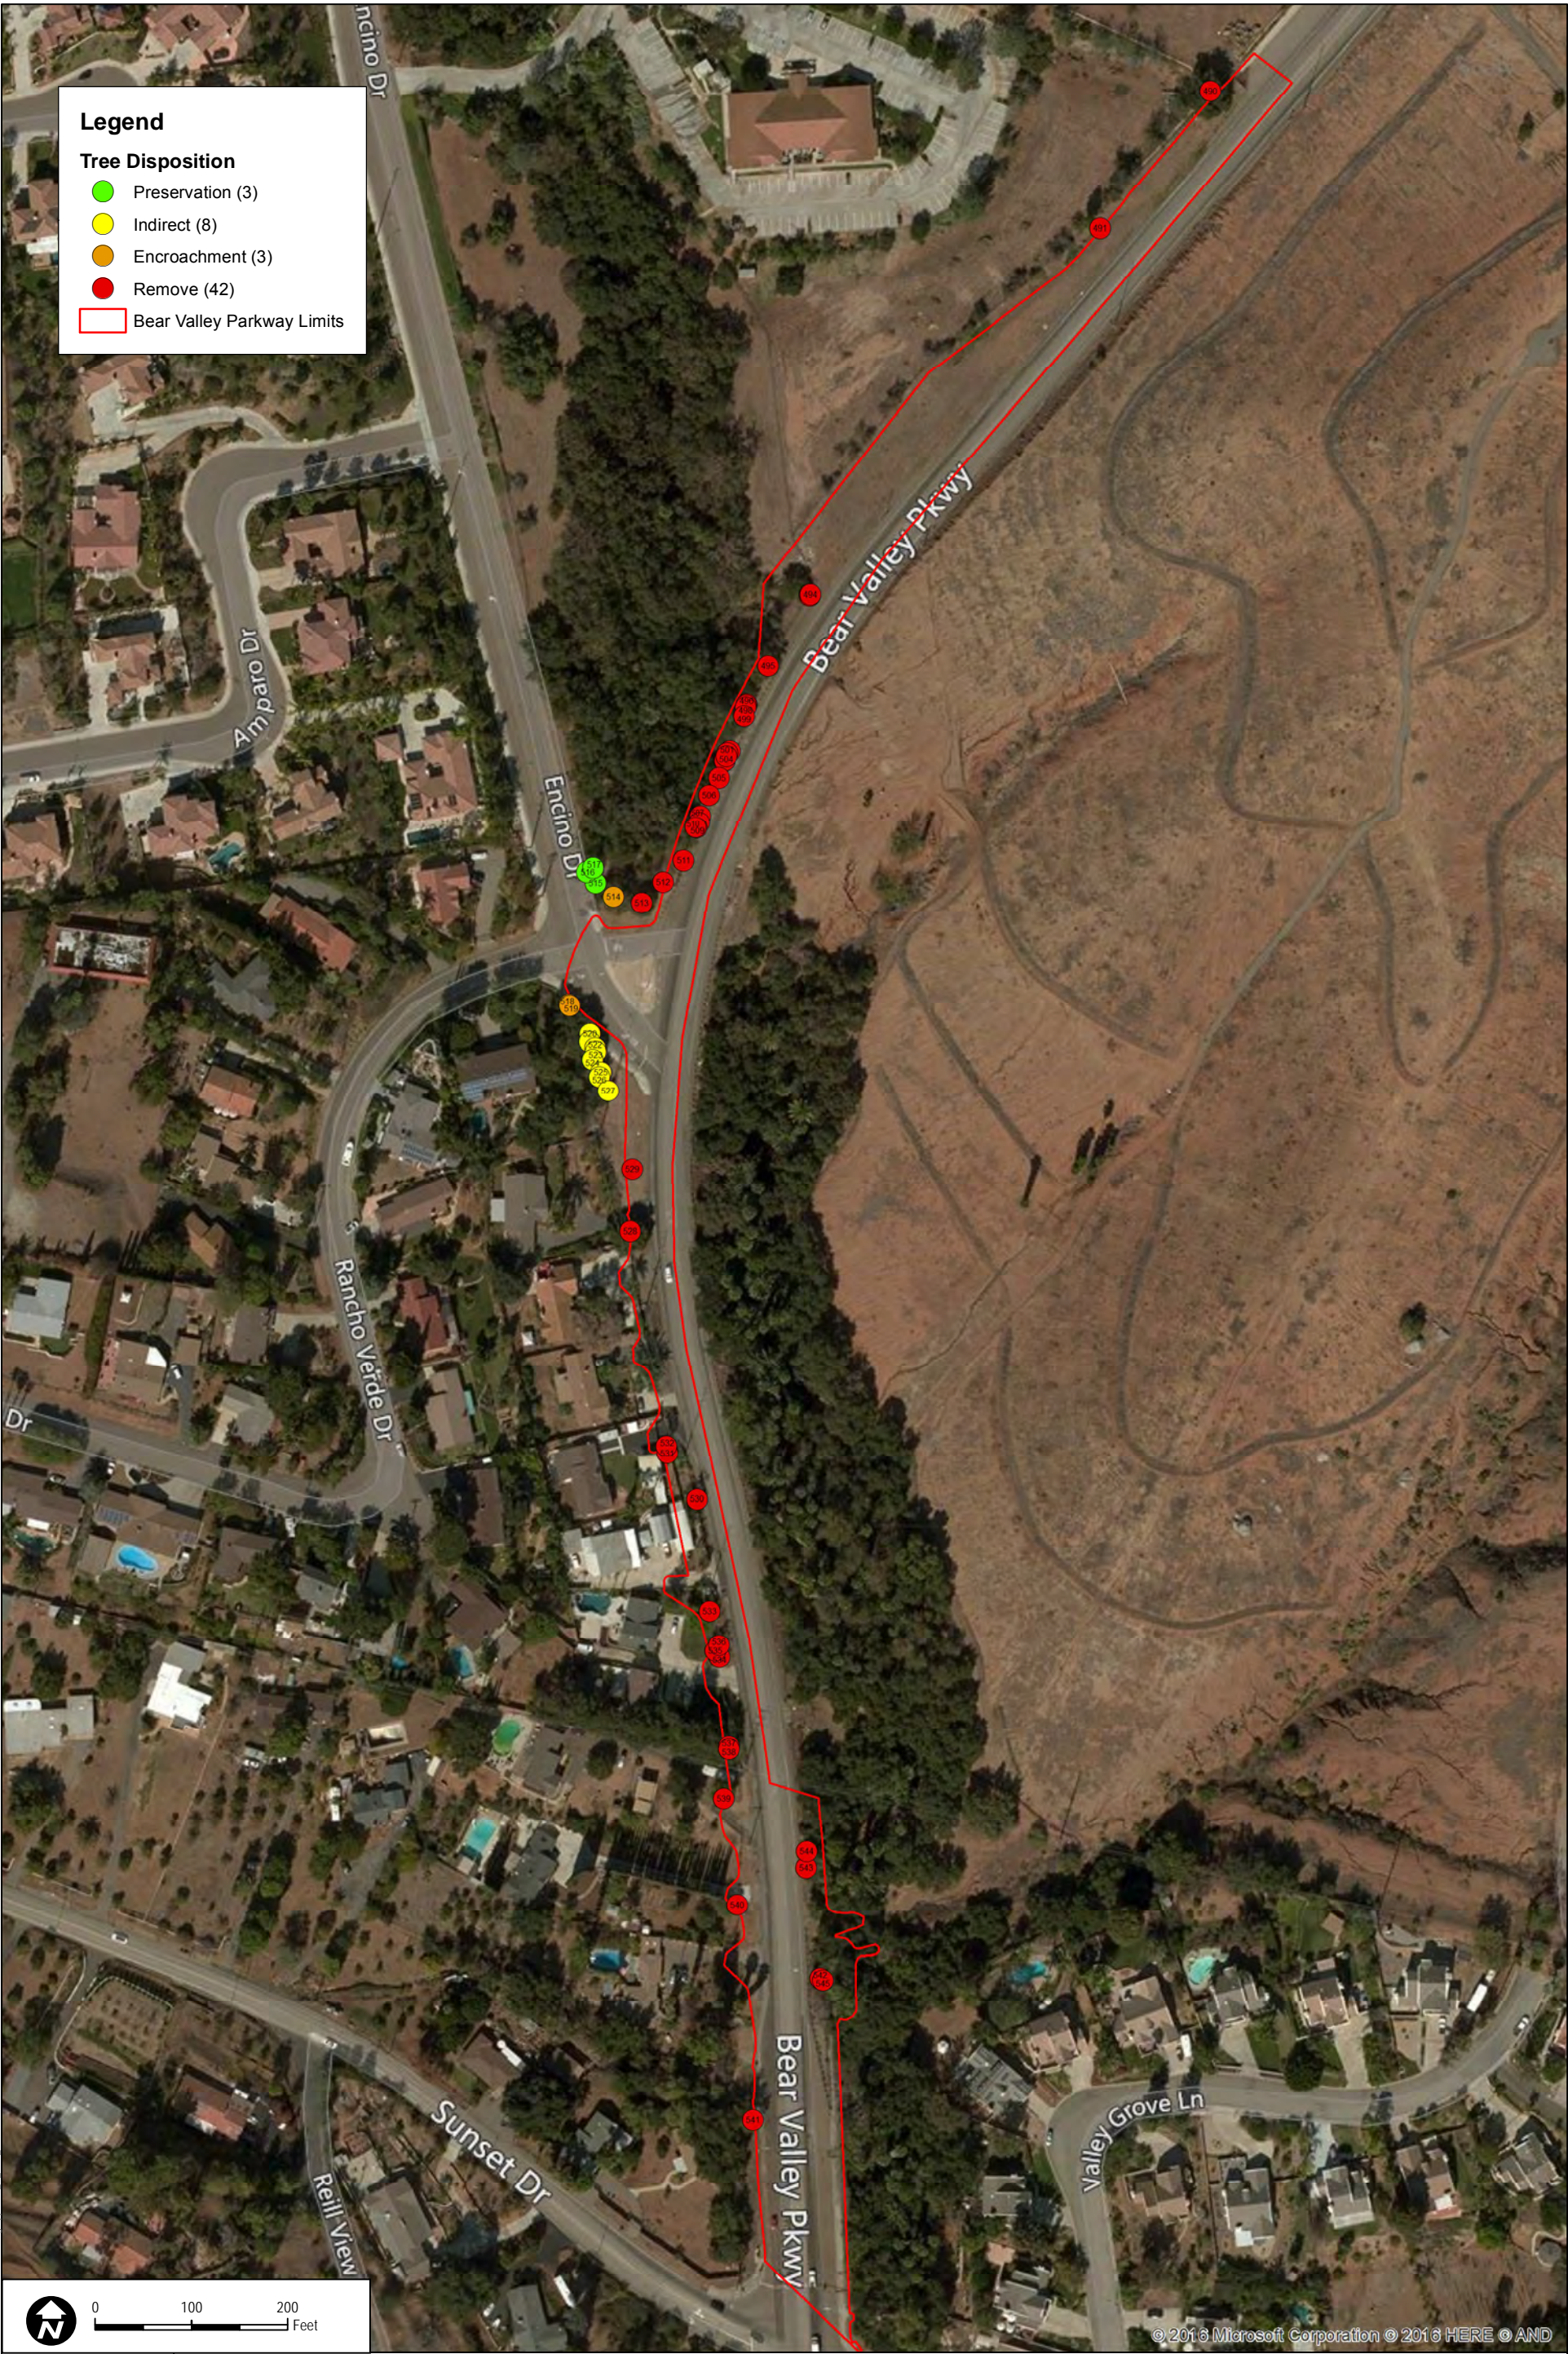
Tree Impacts

Based on proposed project development plans, it is estimated that 42 (75%) mature and protected trees will require removal, 3 (5%) will experience encroachment into the tree protected zone, 8 (15%) will be indirectly impacted, and 3 (5%) will be preserved in place with no direct impacts. Of the 42 trees identified for removal, 14 meet the criteria for classification as a protected tree, as defined by the City. Of the three encroached-upon trees, one meets the size criteria to be classified as a protected tree.

In total, eight coast live oak trees will be indirectly impacted by the project. Of the eight trees, three are considered protected by the City. None of the ornamental trees are anticipated to be indirectly impacted by the proposed project. Should any of the indirectly impacted trees fail within 5 years of project completion, they should be replaced in accordance with City requirements. Locations of impacted trees, by impact type, are presented on the map in Appendix C.
