**Historic Building Evaluation of the
Palm Tree Motor Lodge and the
Wagon Wheel Restaurant at
425 West Mission Avenue,
Escondido, California**

Prepared for
OnPoint Development
7514 Girard Avenue, Suite 1515
La Jolla, CA 92037
Contact: Mr. Todd Dwyer

Prepared by
RECON Environmental, Inc.
1927 Fifth Avenue
San Diego, CA 92101
P 619.308.9333

RECON Number 8478
May 5, 2017

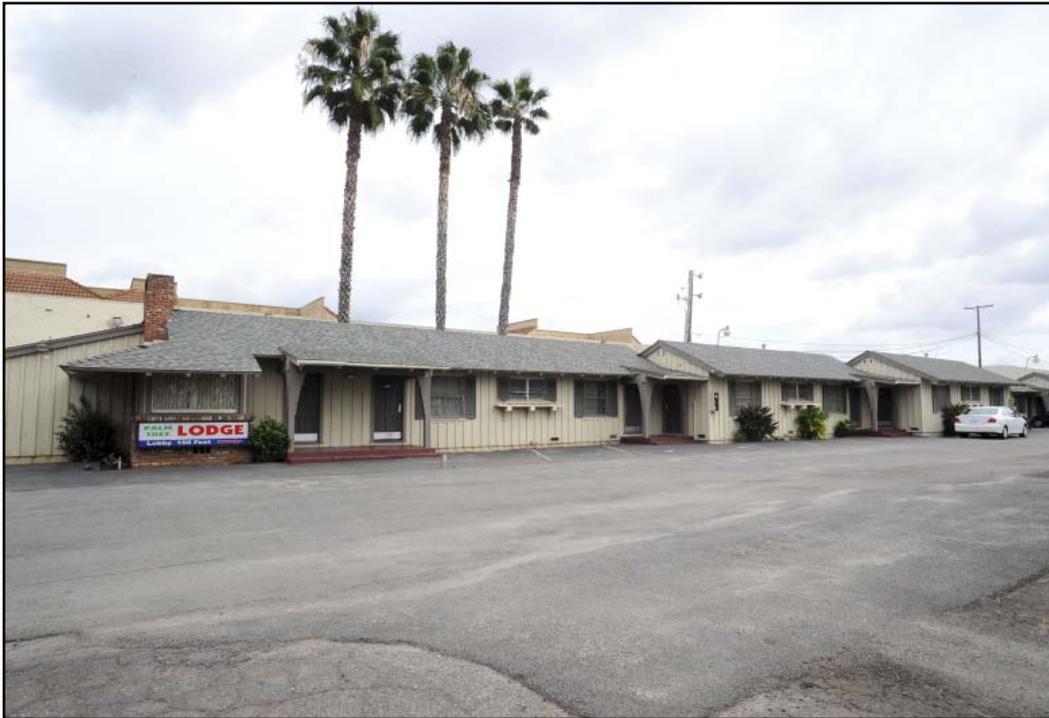
As noted above, the floorplan of the main lodge building resembles a series of small duplexes joined together end to end (Photograph 1). The attachment is staggered approximately seven feet, so the façade is an alternating, set forward, set back wall. Each duplex segment has a low pitched, end gabled roof. Roofing is currently composition shingles, but the Commercial Building Record lists shake shingles as the original roofing material. Eaves on the gable ends are close raked, with a fascia board against the wall (Photograph 2). There are two vent holes, set below the gable apex, that are designed to look like birdhouse entrances with small landing platforms. Eaves on the front and back of the segments are open, with an overhang of approximately 24 inches. The exposed rafters are 6-by-12-inch beams with rounded tails and no fascia board. The roof edge is covered by a metal coping.

PHOTOGRAPH 1
North End of Palm Tree Lodge, Looking Southeast

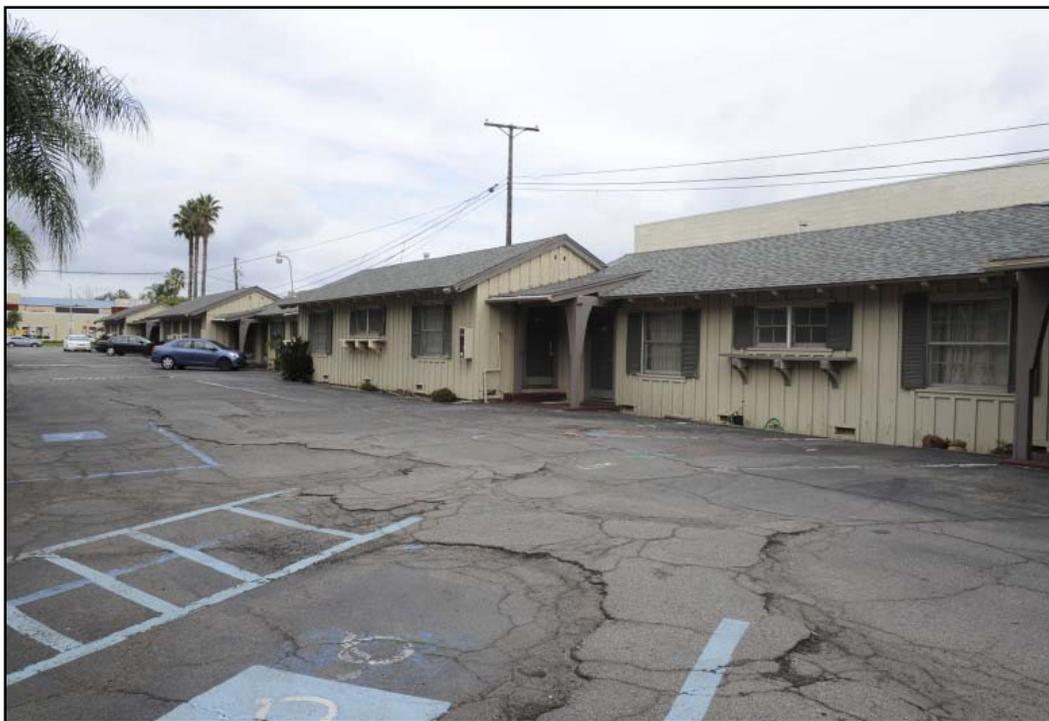
PHOTOGRAPH 2
Looking Northeast at the Main Lodge
Building, Showing Roofs and Eaves

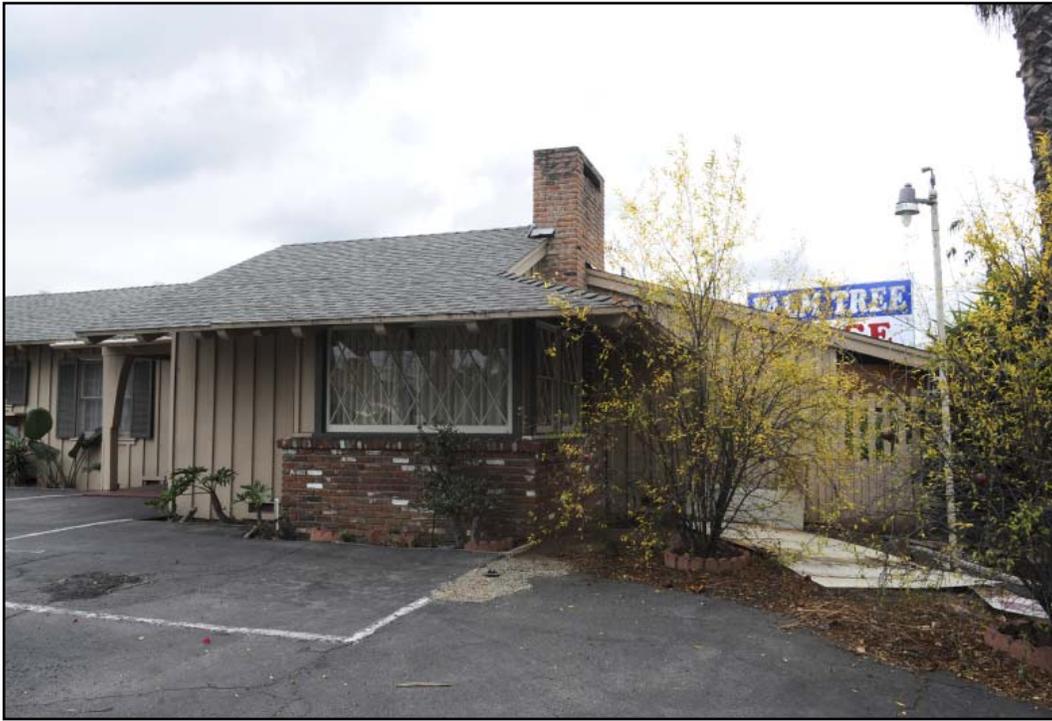
There are three chimneys constructed of used red brick; one each at the far ends of the building and one on the south end of the office segment (Photograph 3). The chimneys are approximately 20 inches by 68 inches by 210 inches high, with the long axis at right angle to the roof long axis. They are built using a running bond. The walls are clad in vertical, rough sawn, board-and-batten. The doors are located at the ends of the segments. On the segments that set forward, the doors are located on the gable ends. On the segments set back, the doors are on the ends next to the wall angles.

PHOTOGRAPH 3
Chimney at South End of Main Lodge Building

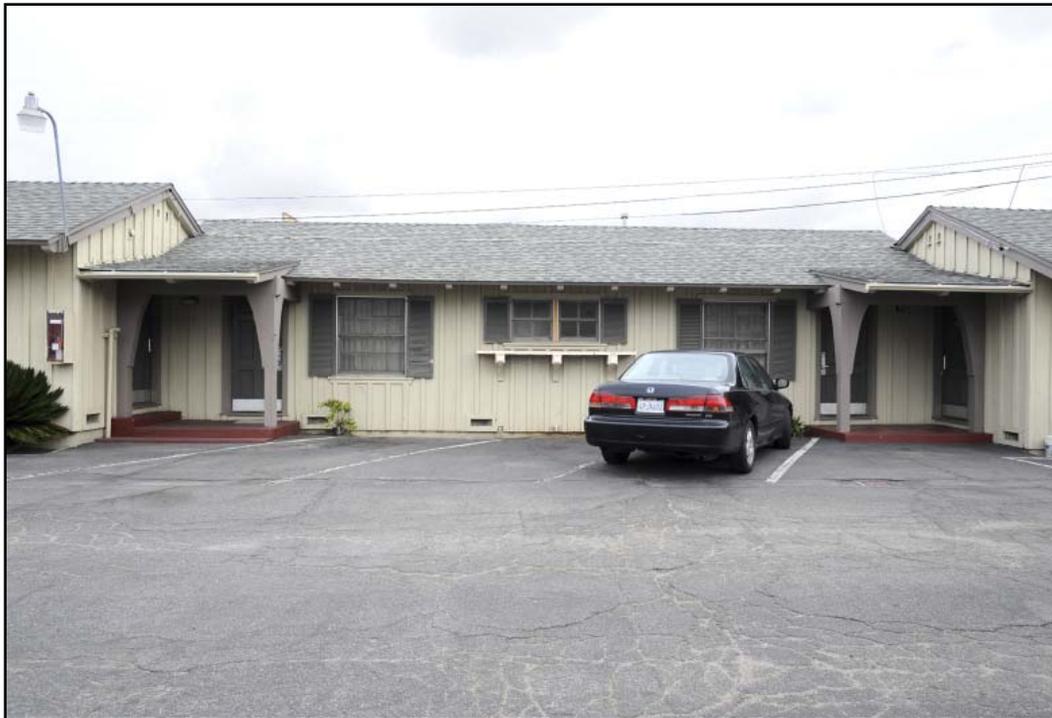
PHOTOGRAPH 4
View Showing Arrangement of Doors and
Windows on Recessed Segment of Façade

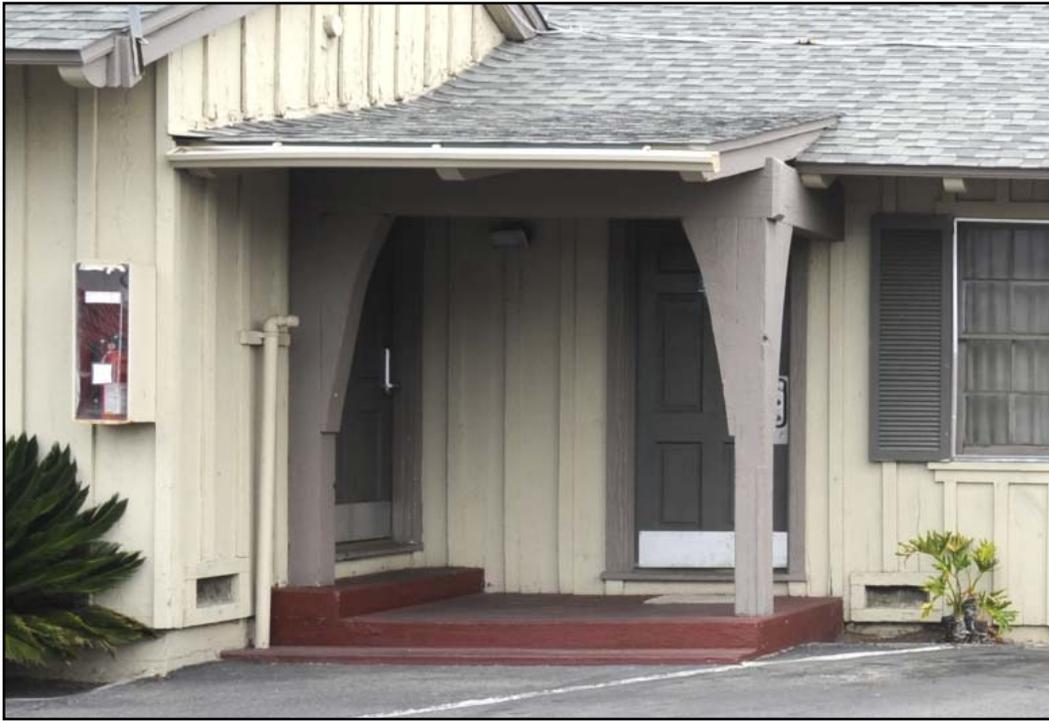
PHOTOGRAPH 5
Close-up of Door, Shed Roof, and Support Posts

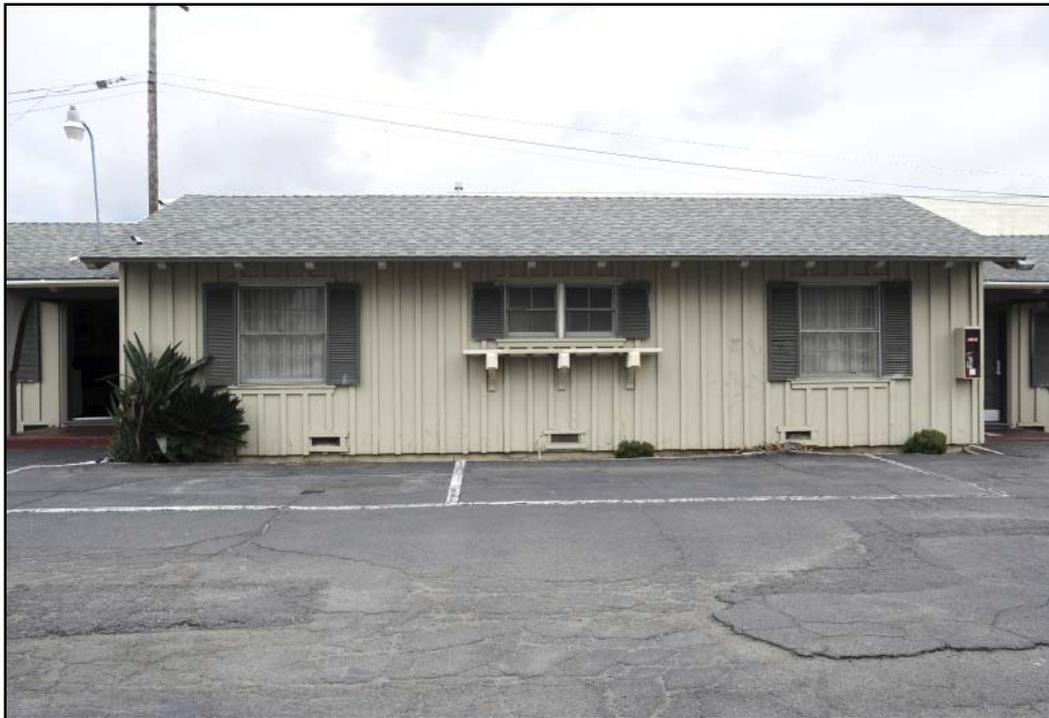
PHOTOGRAPH 6
Arrangement of Windows on Projecting Lodge Segment

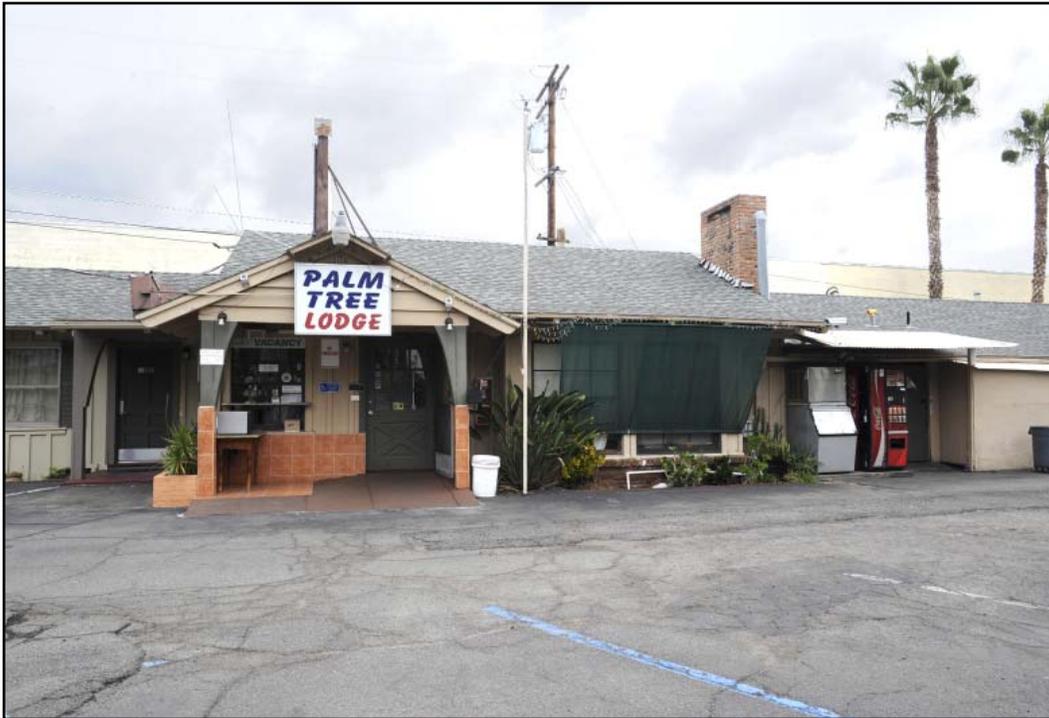
The office/lobby segment is located towards the south end of the long (north-south) arm of the lodge (Photograph 7). The entrance door is set to the left of center. An end gabled roof covers the door and a window set on the left of the door. The gable eaves are close raked, with a fascia board. The gable is clad with horizontally set, lapped wood boards. The side eaves area open and match the other open eaves in design. A lightbox sign is affixed in the gable, and an older lightbox sign sits on the north side of the roof, visible from the north. The roof is supported by two posts styled to match the other roof support posts. The door has a fixed, nine-light upper half and a lower half with four triangular panels. The window is nine over nine double, hung, with wood frame and casing. A shelf has been added in front of the window, attached to the window casing. The area below the window and the bottom one-half of the posts have been faced with glazed tiles. The tiles are 12-inch squares and have a mottled terra cotta glaze. These tiles are definitely a later addition. To the right of the entrance is a pair of large windows, separated by a wood mullion. The windows are six-over-six, double hung, with wood frames and narrow wood casings. The eaves over these windows match the other open eaves on the lodge. The wall below the windows has been clad with red used brick. To the south of the lobby is what appears to be a storage room, with a door in the west wall and a door on the south wall (Photograph 8). A small shed has been added to the front of the storage room, made of plywood and roofed with corrugated sheet metal. A corrugated sheet metal roof has also been added between this shed and the lobby roof to cover an ice machine and soda dispenser (see Photograph 7).

PHOTOGRAPH 7
Lodge Office/Lobby Façade

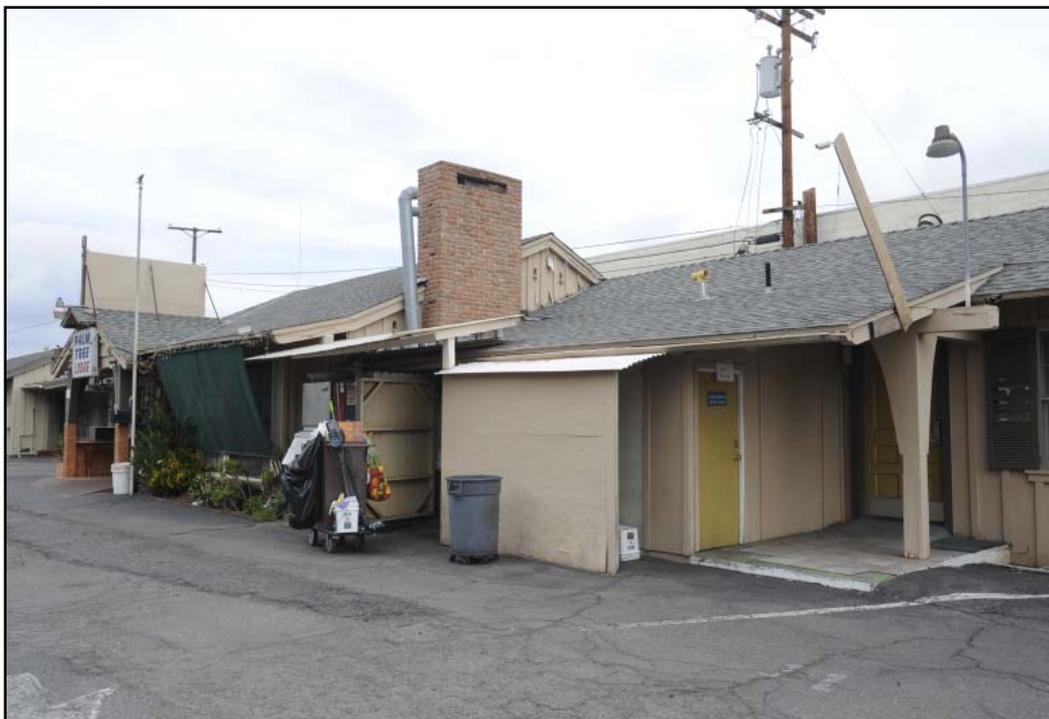
PHOTOGRAPH 8
Storage Area South of Office/Lobby

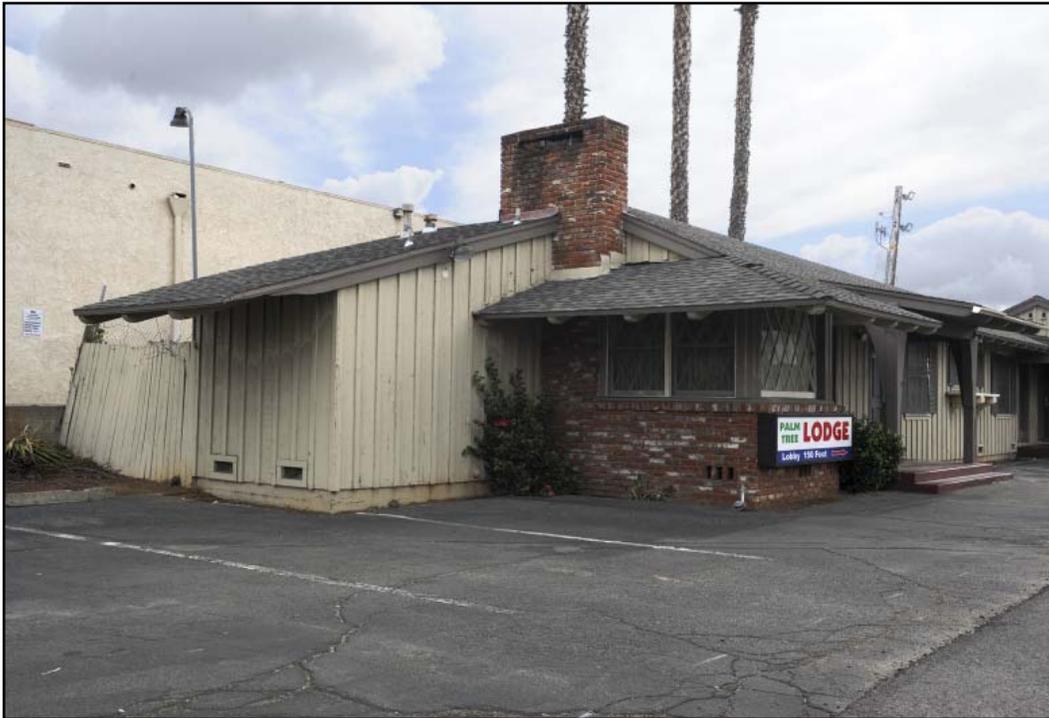
The end segments of the main building have small rooms on the outside corners, faced with used red brick and partial hipped roofs (Photograph 9). Each end room has large corner windows. The windows have diamond lights and wood frames. As noted above, each end room has a rectangular red brick chimney, with the long axis oriented at right angle to the long axis of the segment. A narrow room sits behind the window rooms. This room has a shed roof oriented the same as the gable ridge of the segment, with close raked eaves and a fascia board against the wall (see Photograph 9).

PHOTOGRAPH 9
North End of Long Leg of Main Lodge Building,
Showing Small Room Roof and Windows

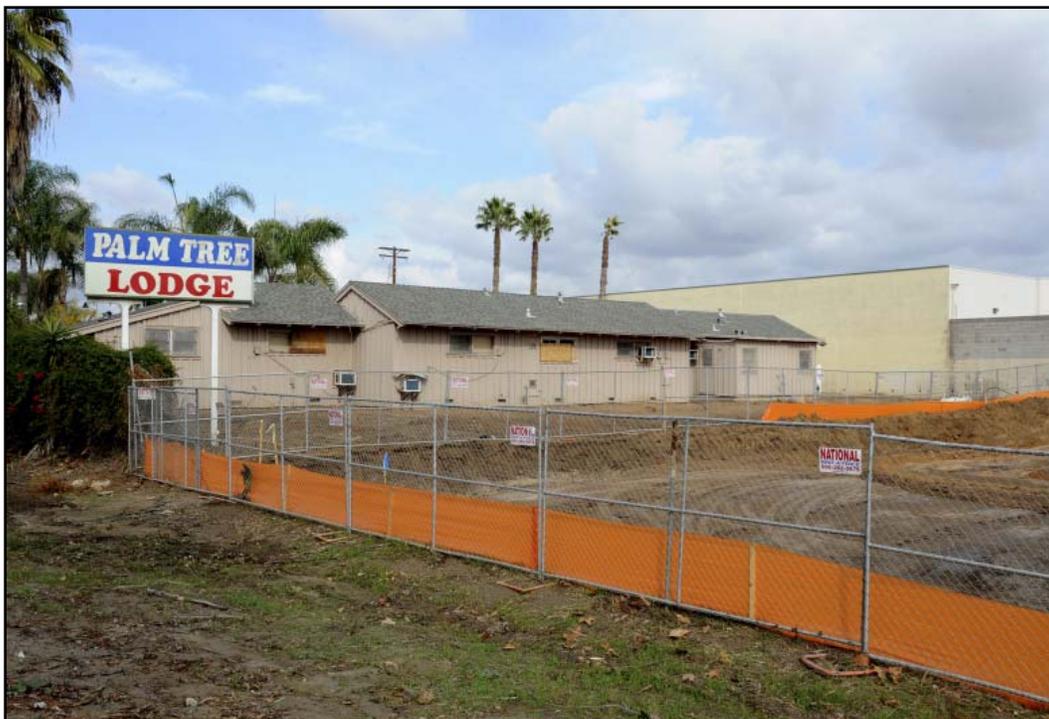
The rears of the lodge segments have one to four rectangular windows, in two sizes, spaced regularly along the segment (Photographs 10 and 11). Windows are one over one, double hung, with wood frames, casings, and sills. The windows of the smaller size are paired, and in many of the pairs air conditioner units have been installed in one of the windows. A number of windows are boarded up, possibly because air conditioning units have been removed. There are wood doors set on the short end of the segments. The visible door has a one over one, double hung, wood frame window in the top half.

PHOTOGRAPH 10
Rear of Short Leg of Main Lodge Building
Showing Window and Door Arrangement

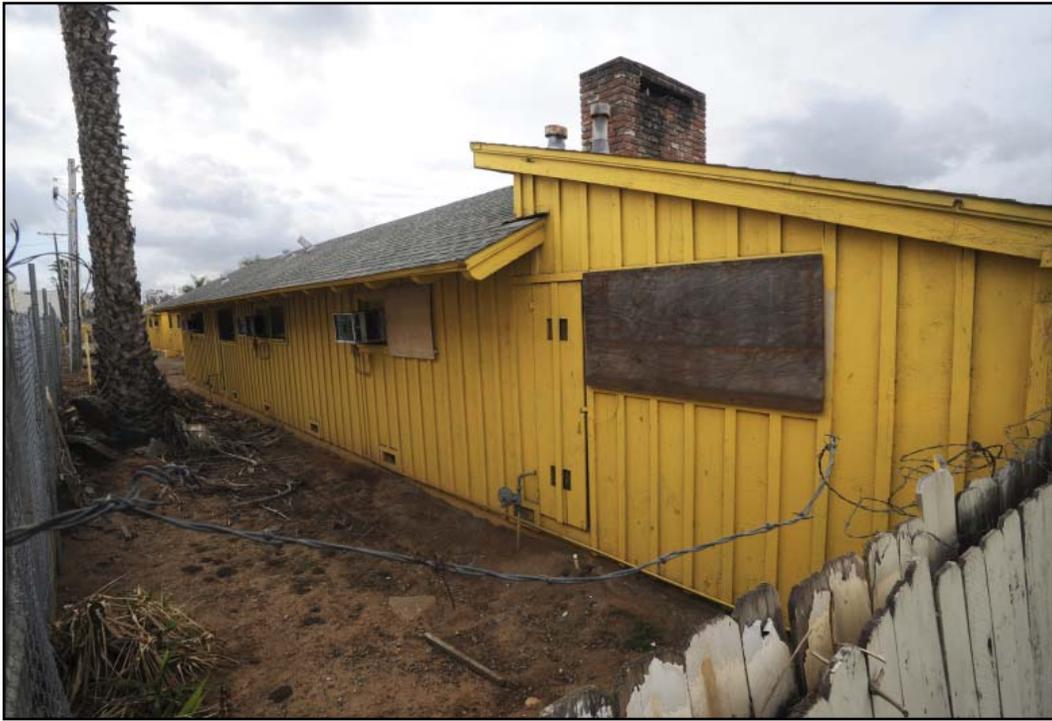
PHOTOGRAPH 11
Rear of Long Leg of Main Lodge Building

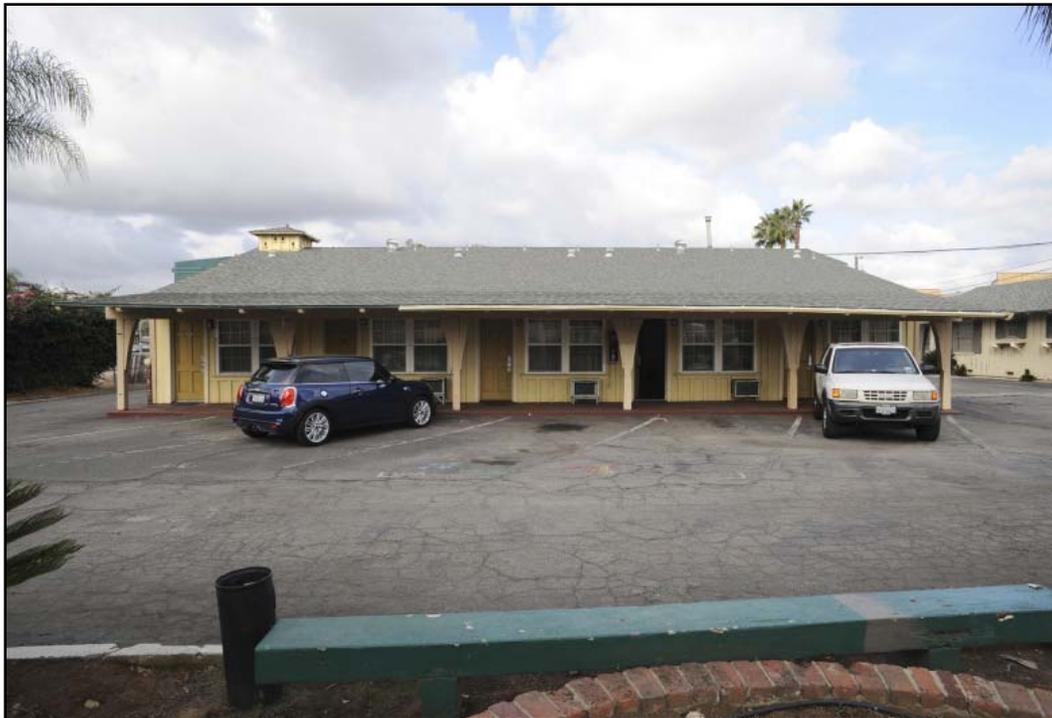
PHOTOGRAPH 12
Second Lodge Building, South Façade

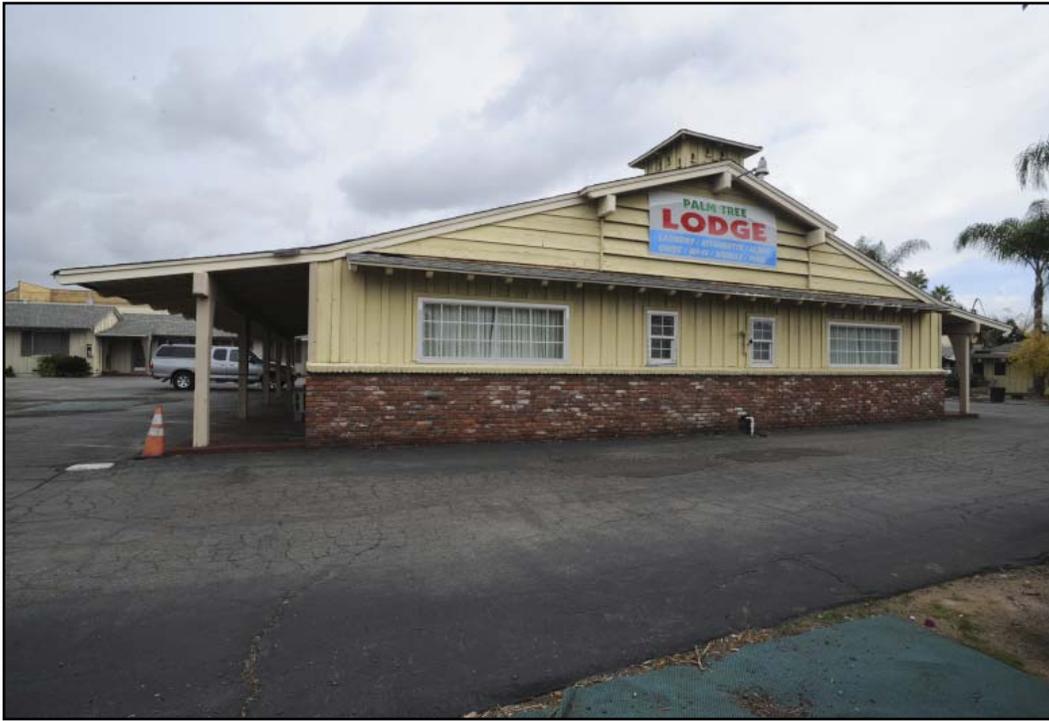
PHOTOGRAPH 13
Second Lodge Building, West Elevation

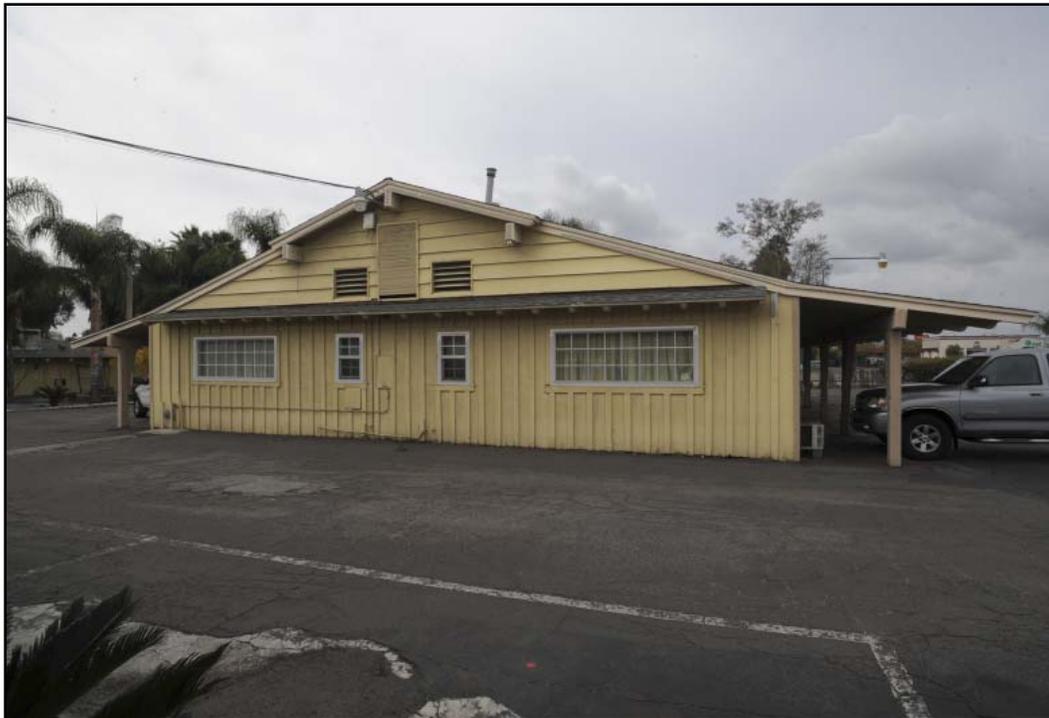
PHOTOGRAPH 14
Second Lodge Building, East Elevation

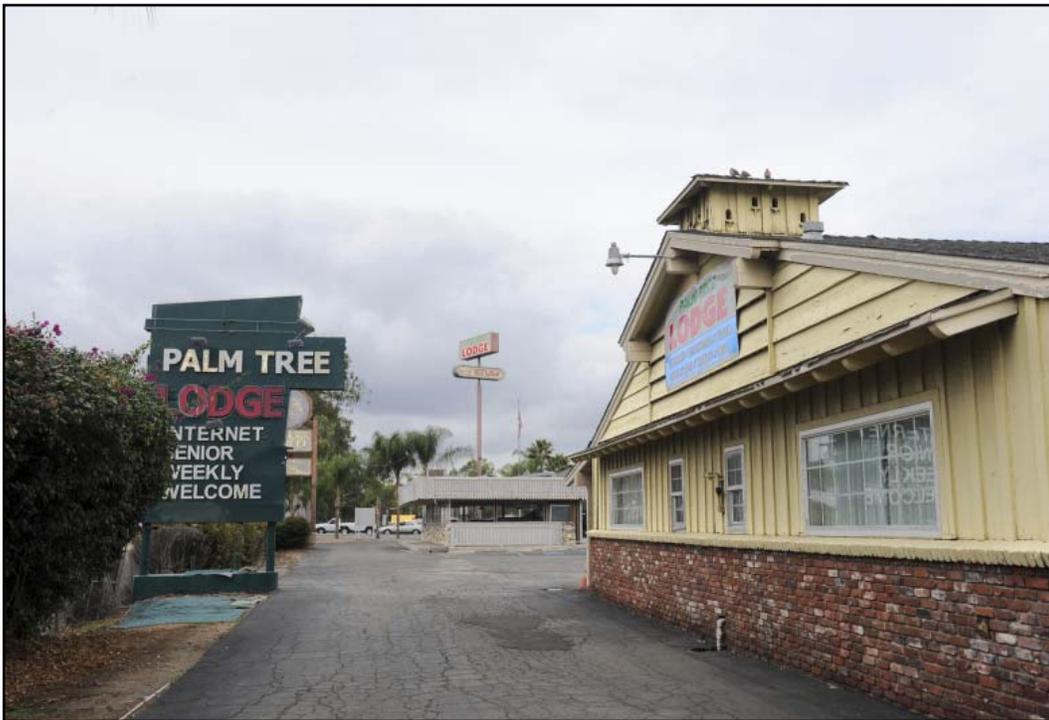
PHOTOGRAPH 15
Second Lodge Building, West Elevation Showing Narrow Shed Roof

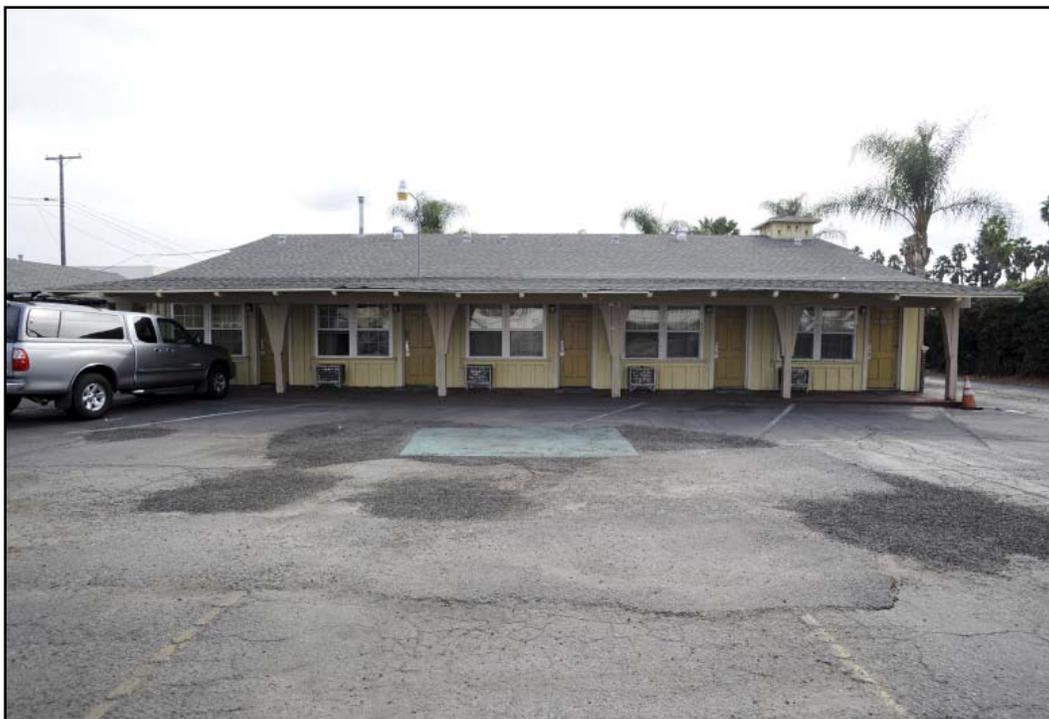
PHOTOGRAPH 16
Second Lodge Building, North Façade,
Showing Door and Window Arrangement

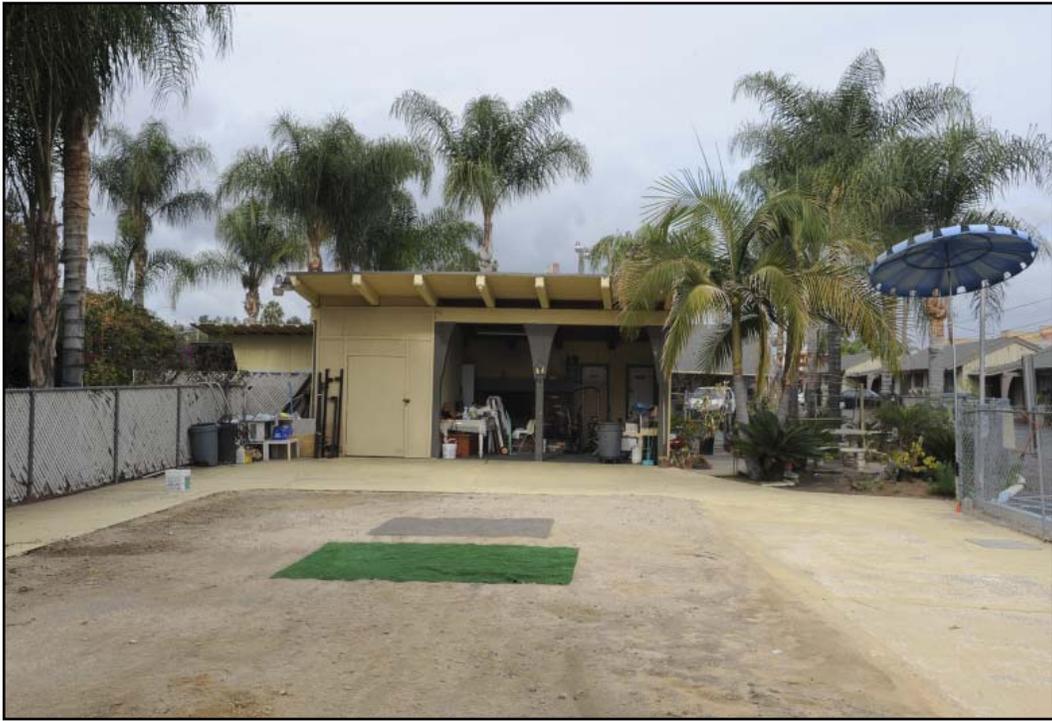
PHOTOGRAPH 17
Cabana, Façade

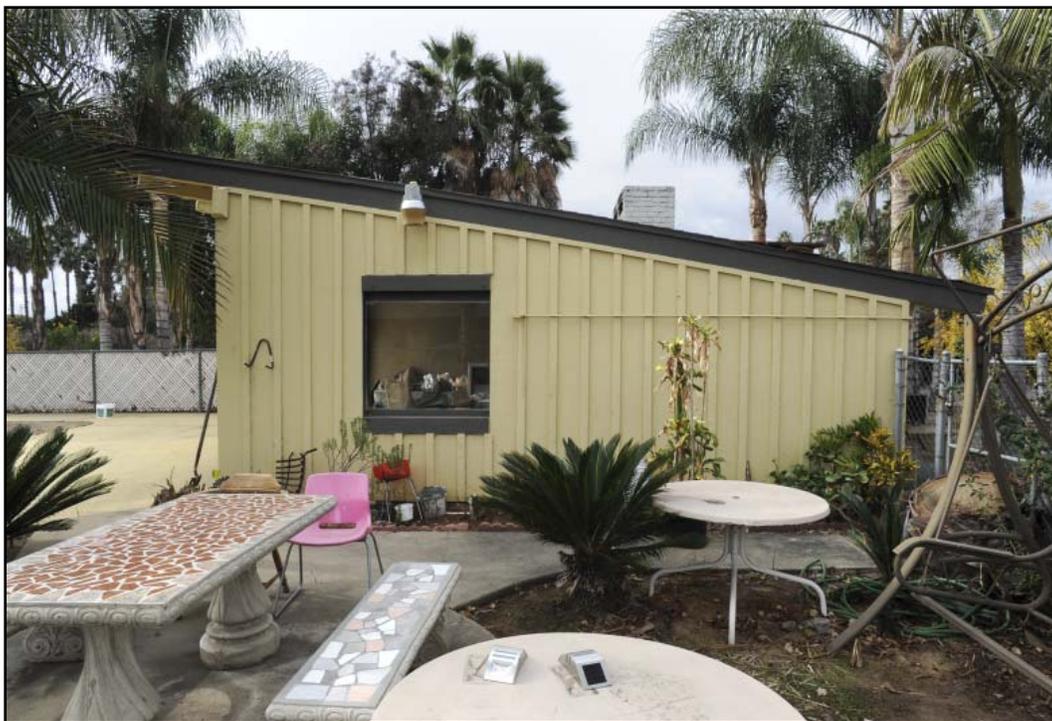
PHOTOGRAPH 18
Cabana, East Elevation

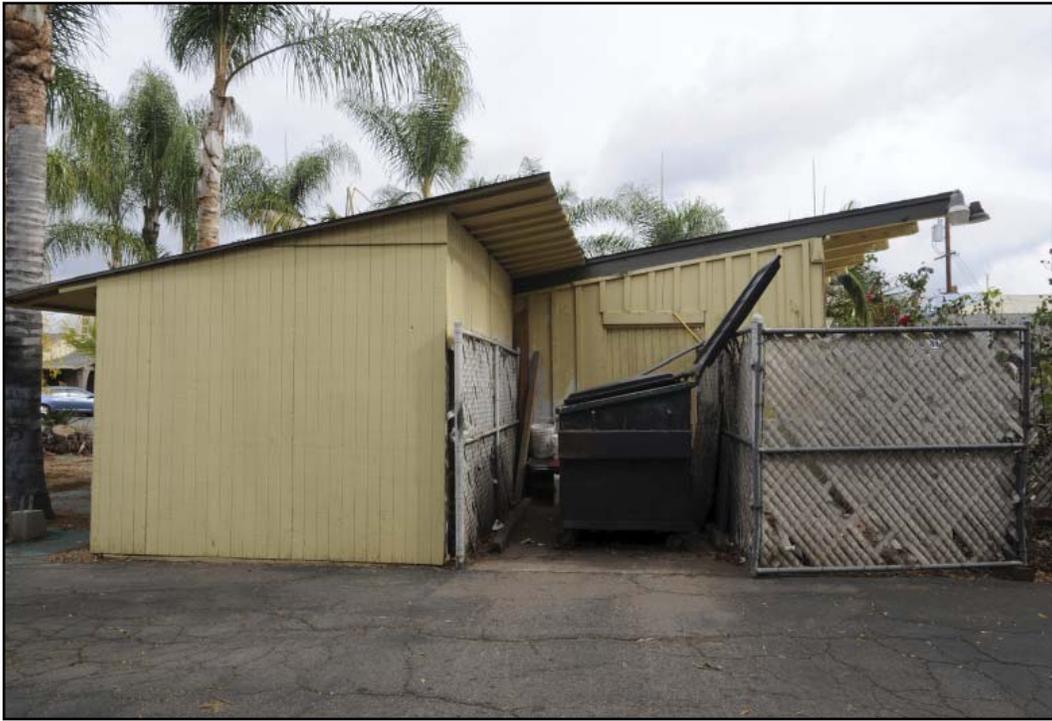
PHOTOGRAPH 19
Cabana, West Elevation

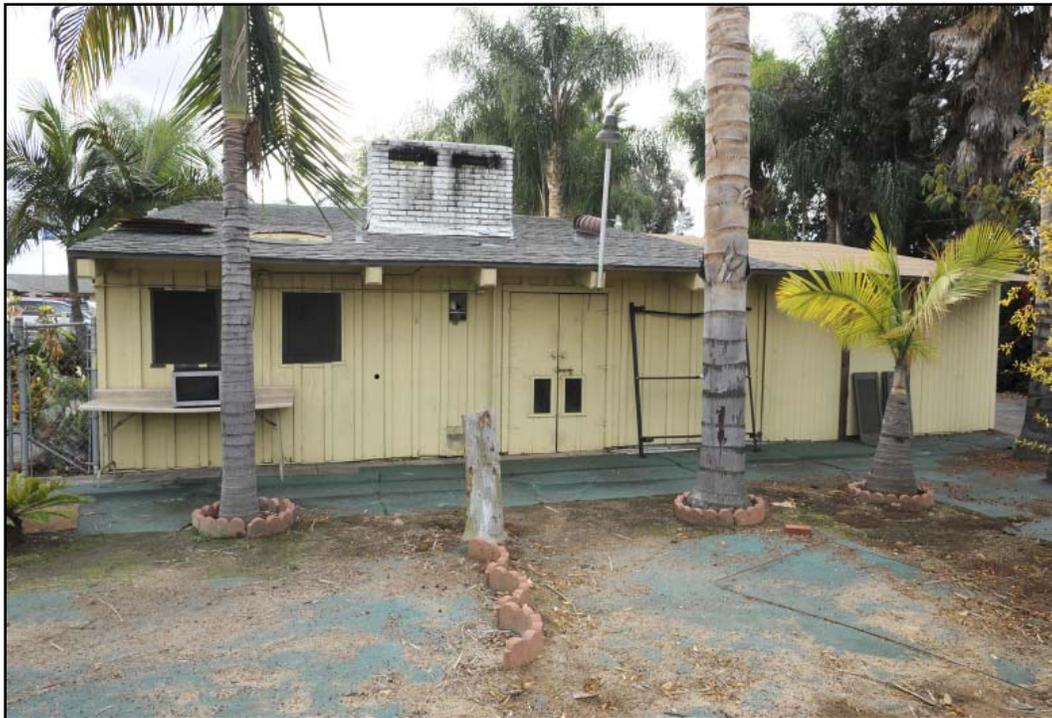
PHOTOGRAPH 20
Cabana, North Elevation

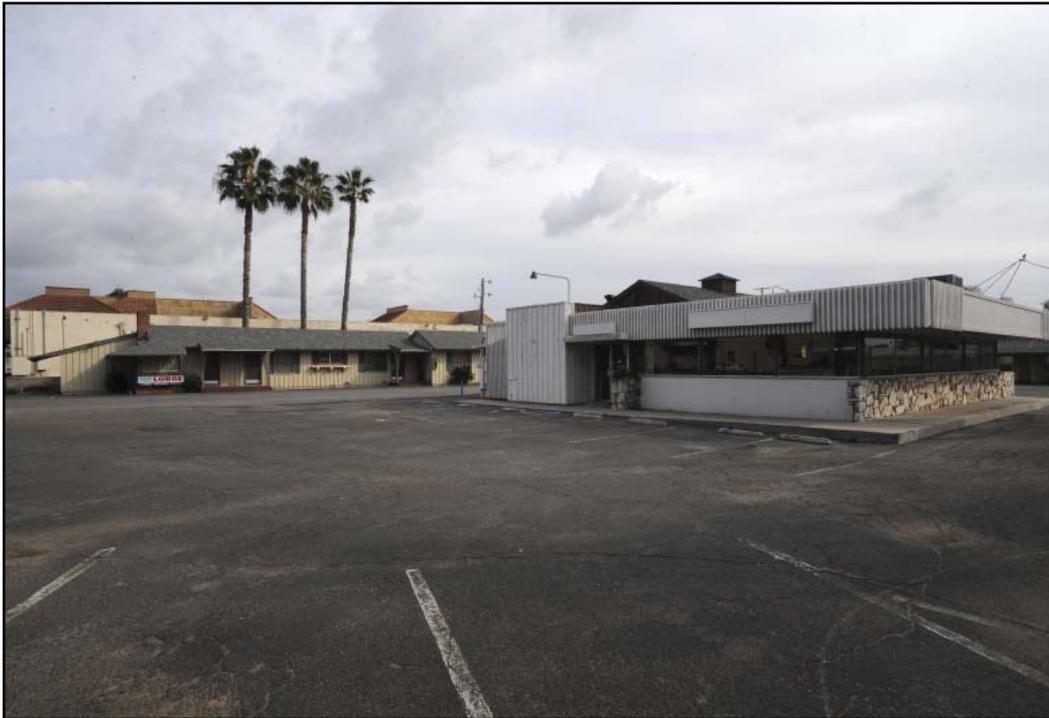
The Wagon Wheel Restaurant is set near the northern end of the project property (Photograph 21). The building currently measures approximately 60 feet (east-west) by 45 feet (north-south). A substantial addition has been constructed on the west side of the original building, which measured approximately 45 feet (north-south) by 32 feet (east-west). The addition measures approximately 25 feet east-west by 45 feet north-south. The original building appears to have shared the same rustic Minimal Traditional architectural style as the lodge, but much of this is now covered or removed. A possible smaller addition across the east side of the building, approximately 6 feet deep, is a storage area. The architectural style of the large western addition is a Contemporary style of architecture, with a strong horizontal orientation, prominent roof form in the marquee, deep overhanging eaves, large windows, and fieldstone exterior cladding.

PHOTOGRAPH 21
View of Wagon Wheel Restaurant Building, Looking Southeast

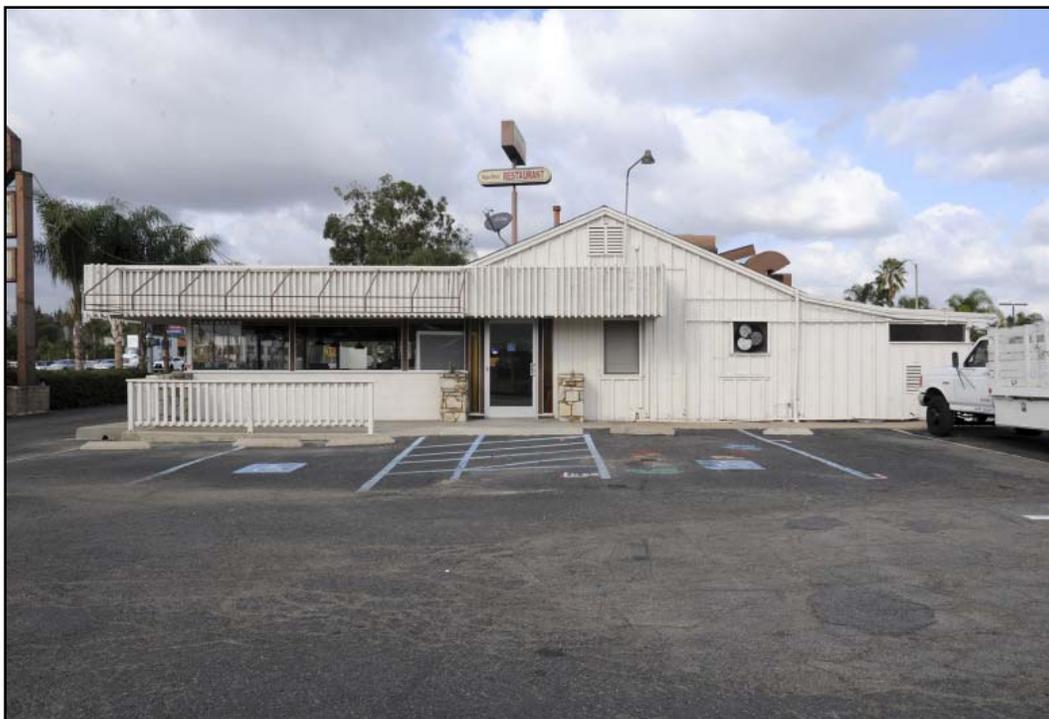
The visible gable eaves on the original portion of the restaurant are close, with a fascia board (see Photograph 22). The eastern addition has open eaves extending out approximately 18 inches, with rounded rafter ends and no fascia board. The western addition has roof extensions on all sides, varying in depth from 1 foot on the north side to 5 feet on the west side (Photograph 23). The roof boards are tongue and groove wood boards. A vertical marquee, approximately 4 feet high, is attached to the roof extension on all three sides of the west addition. On the west (façade), the marquee is attached to the beams that support the roof extension. The marquee is constructed of plywood with 2-by-3-inch vertical slats spaced approximately 6 inches apart on the façade face. The central portion of the façade false front is flat, and was probably used for a sign when the restaurant was in business (Photograph 24).

PHOTOGRAPH 22
Restaurant, South Elevation, Showing Roof Configuration

The door on the south wall is a single, glass storefront door with narrow sidelights (see Photograph 22). The sidelights are fixed and the glass is textured and amber in color. There are short, low walls faced in fieldstone that flank the door on both sides. To the left (west) of the doors is a set of ribbon windows, consisting of three large fixed lights with metal frames and wood mullions. Above the windows, the wall is cladded with wood board-and-batten, and below it is stuccoed. The wall to the right of the door is the original building wall, cladded in board-and-batten (see Photograph 22). Close to the door is a louvered glass window with wood frame and coping. East of the window is an exhaust fan set in what appears to be a partially blocked in window. Near the top of the gable is a rectangular louvered vent. On the eastern addition portion of the wall is a single screened rectangular opening, set just below the roof eaves.

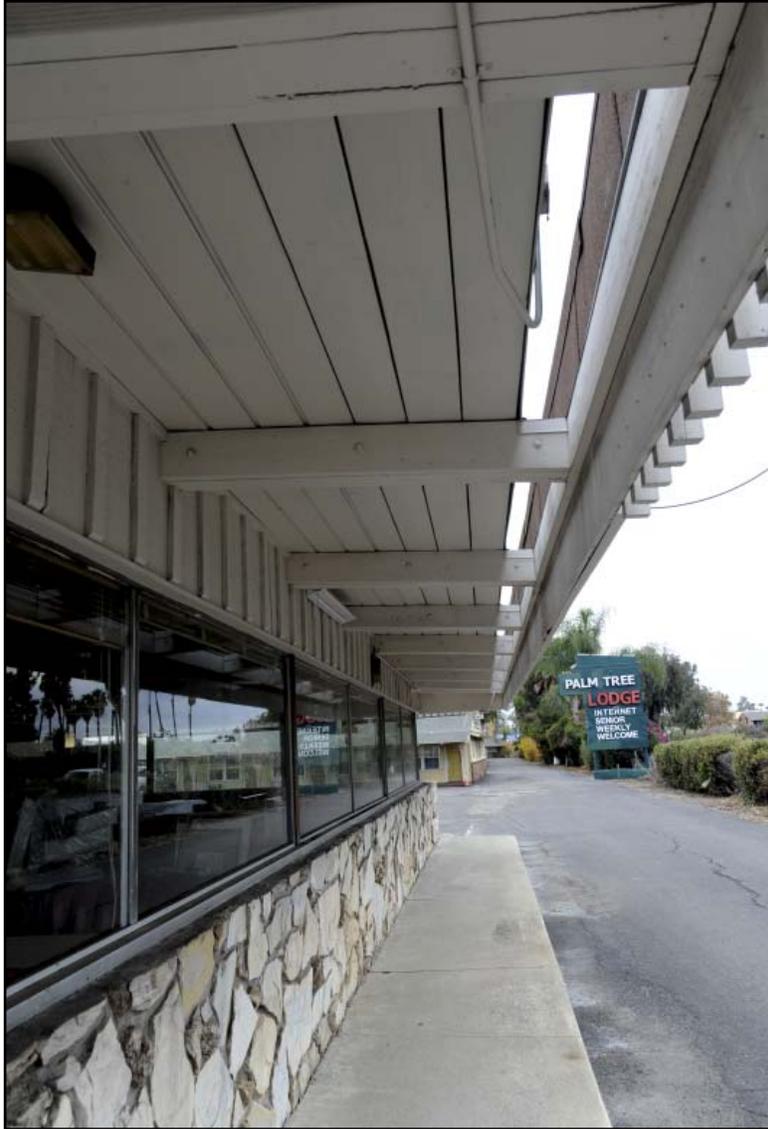
PHOTOGRAPH 23
Restaurant, View of Overhang
and Marquee on Façade

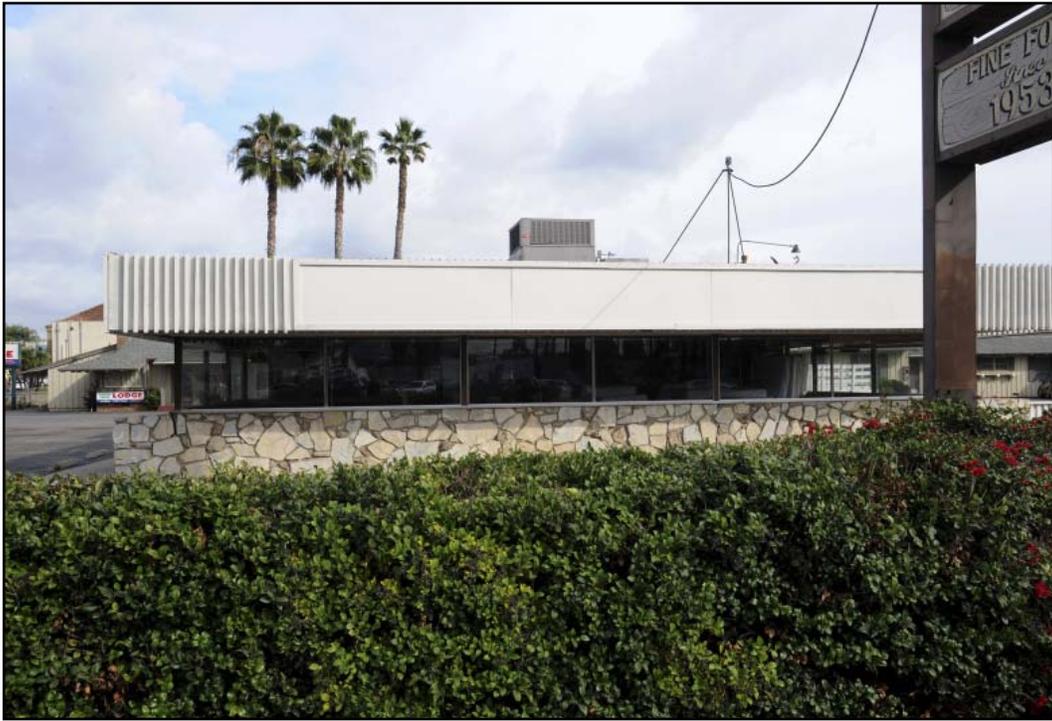
PHOTOGRAPH 24
Restaurant, Façade Showing Flat Area on Marquee

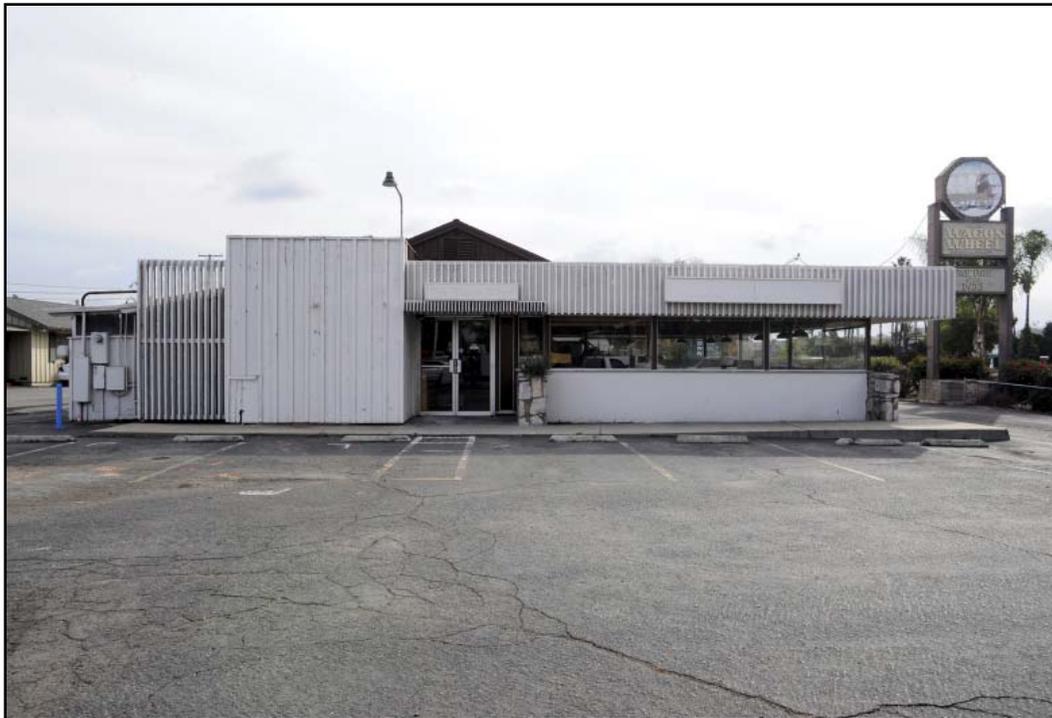
PHOTOGRAPH 25
Restaurant, North Elevation
Showing Entrance Doors and Other Details

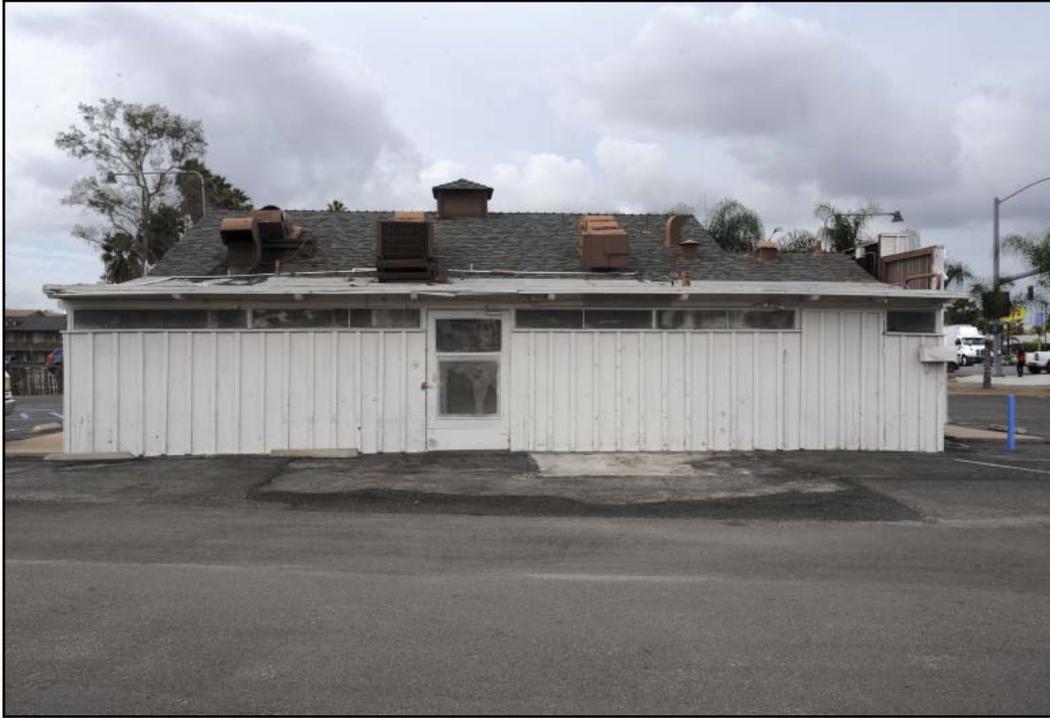
PHOTOGRAPH 26
Restaurant, East Elevation
