**Historic Building Evaluation of the
Palm Tree Motor Lodge and the
Wagon Wheel Restaurant at
425 West Mission Avenue,
Escondido, California**

Prepared for
OnPoint Development
7514 Girard Avenue, Suite 1515
La Jolla, CA 92037
Contact: Mr. Todd Dwyer

Prepared by
RECON Environmental, Inc.
1927 Fifth Avenue
San Diego, CA 92101
P 619.308.9333

RECON Number 8478
May 5, 2017

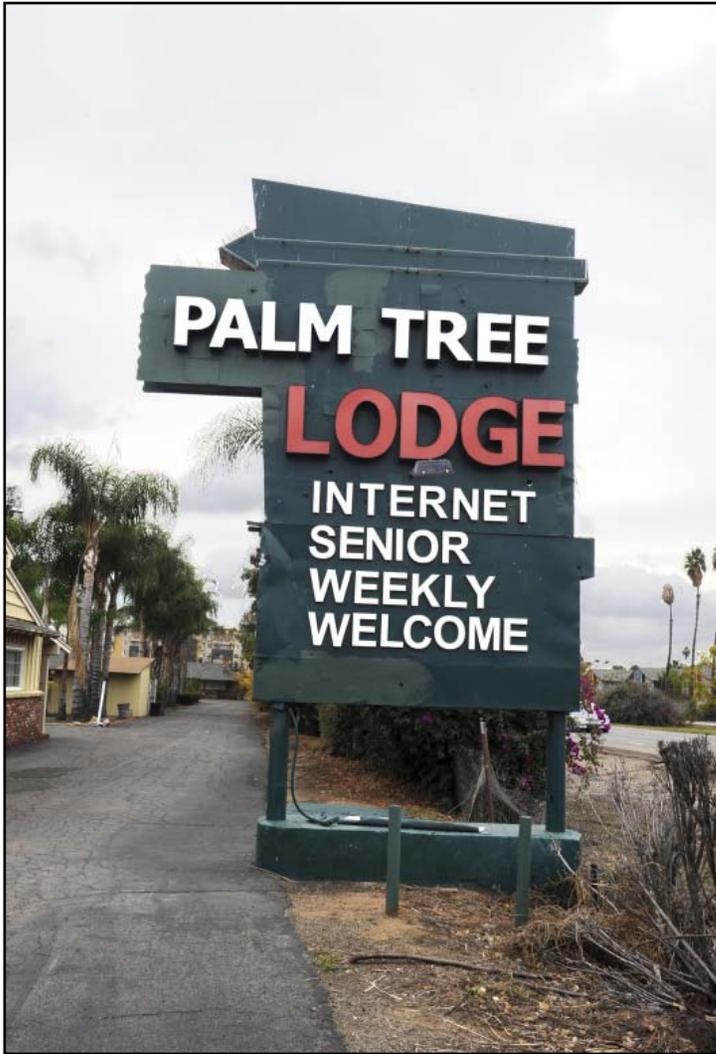
There are two freestanding signs on the project property that are 50 or more years old: one for the “Palm Tree Lodge” and one for the Wagon Wheel Restaurant. The sign for the Palm Tree Lodge is a rectangular metal sign supported by two pipe legs, set in a poured concrete base (Photograph 27). The sign is approximately 10 feet high and 4 to 5 feet wide, and is oriented north-south to be visible from Centre City Parkway. The sign body is painted dark green. At the top is a neon arrow pointing east to the lodge buildings. Below the arrow are the words “PALM TREE,” and below those the word “LODGE,” in sans-serif font in dimensional form. These letters may be lighted. Below these are the words “INTERNET,” “SENIOR,” “WEEKLY,” and “WELCOME” on separate lines. These words are in flat, sans-serif font metal letters. Style and placement of lettering is the same on both sides of the sign.

PHOTOGRAPH 27
Palm Tree Motor Lodge Sign

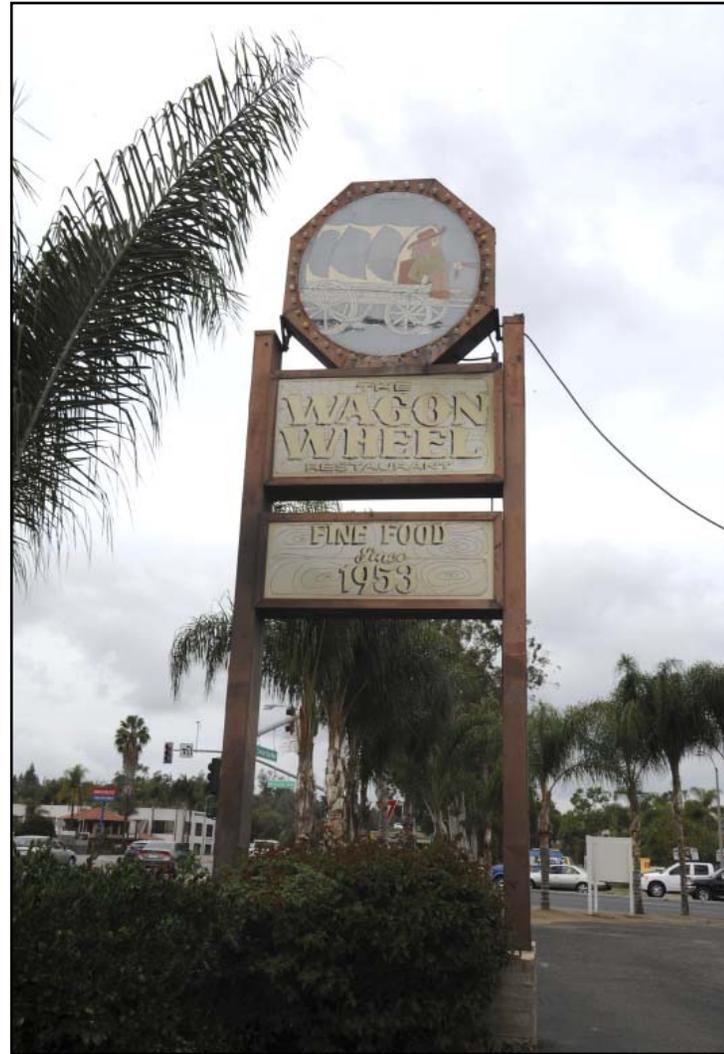
The Wagon Wheel Restaurant sign is a metal sign composed of three panels, two rectangular and one octagonal, supported by two rectangular metal legs (Photograph 28). The metal portions of the sign are painted in a now faded medium brown color. This sign is also oriented north-south, to be seen from Centre City Parkway. The octagonal panel is the topmost, and consists of a metal frame holding round translucent panels with a bearded man driving a wagon painted on them. Small light bulbs set in the metal frame circle the panels. The octagonal panel sits on the middle, rectangular metal framed panel. This panel also has translucent panels on which the words “THE WAGON WHEEL RESTAURANT” are painted. The words “WAGON WHEEL” are bold and in a serif western style font, while the words “THE” and “RESTAURANT” are smaller and in a sans-serif font.

PHOTOGRAPH 28
Wagon Wheel Restaurant Sign

Behind the words are painted wood logs. The bottom panel is separated from the middle panel, although also consisting of a metal frame with translucent panels. On this panel, the words “FINE FOOD Since 1953” are painted. The words “FINE FOOD” are in a plain serif font while “Since” is in script. The background also has a painted log design. The three panels are illuminated internally.

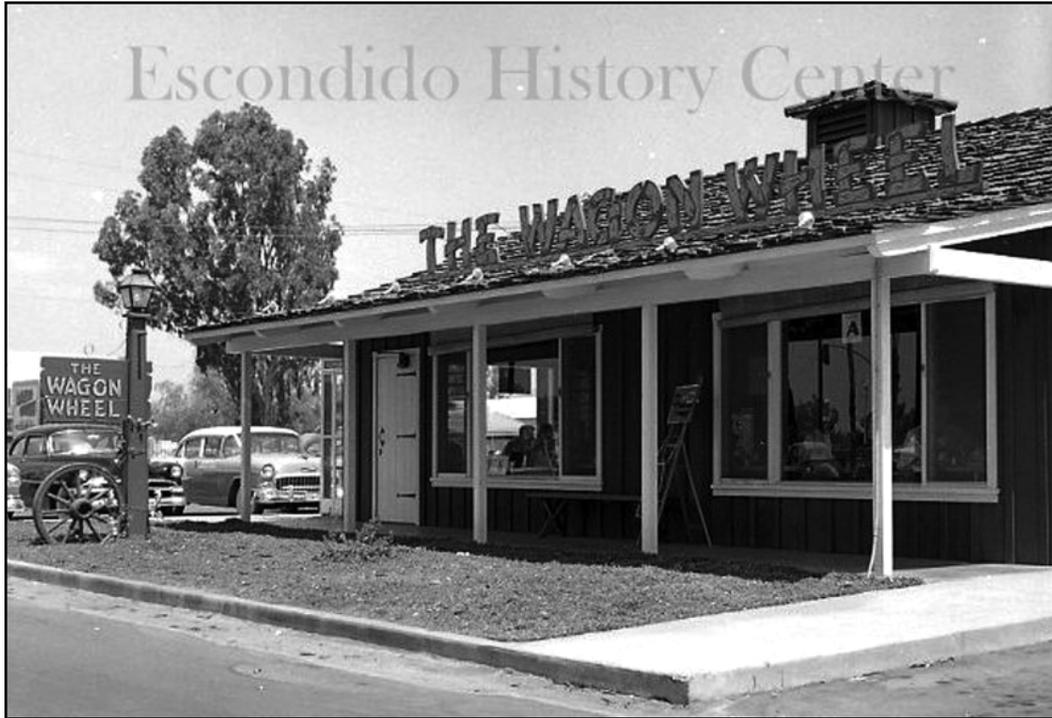
PHOTOGRAPH 29
Historic Photograph of Wagon Wheel
Restaurant Showing Original Façade

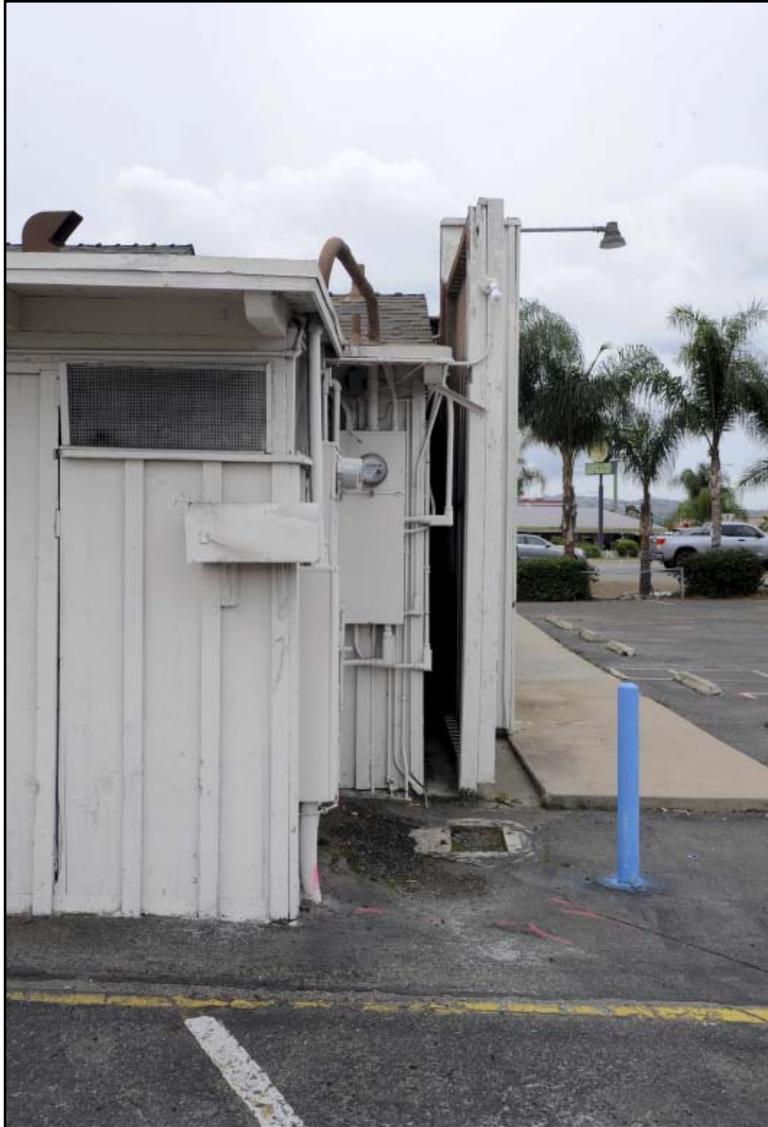
PHOTOGRAPH 30
Northeast Corner of Wagon
Wheel Restaurant Showing Jog in
Building and Electrical Box Location
