**Biological Resources Technical Report for
2351 Meyers Avenue, Escondido, California**

OnPoint Development

DUDEK

JULY 2021

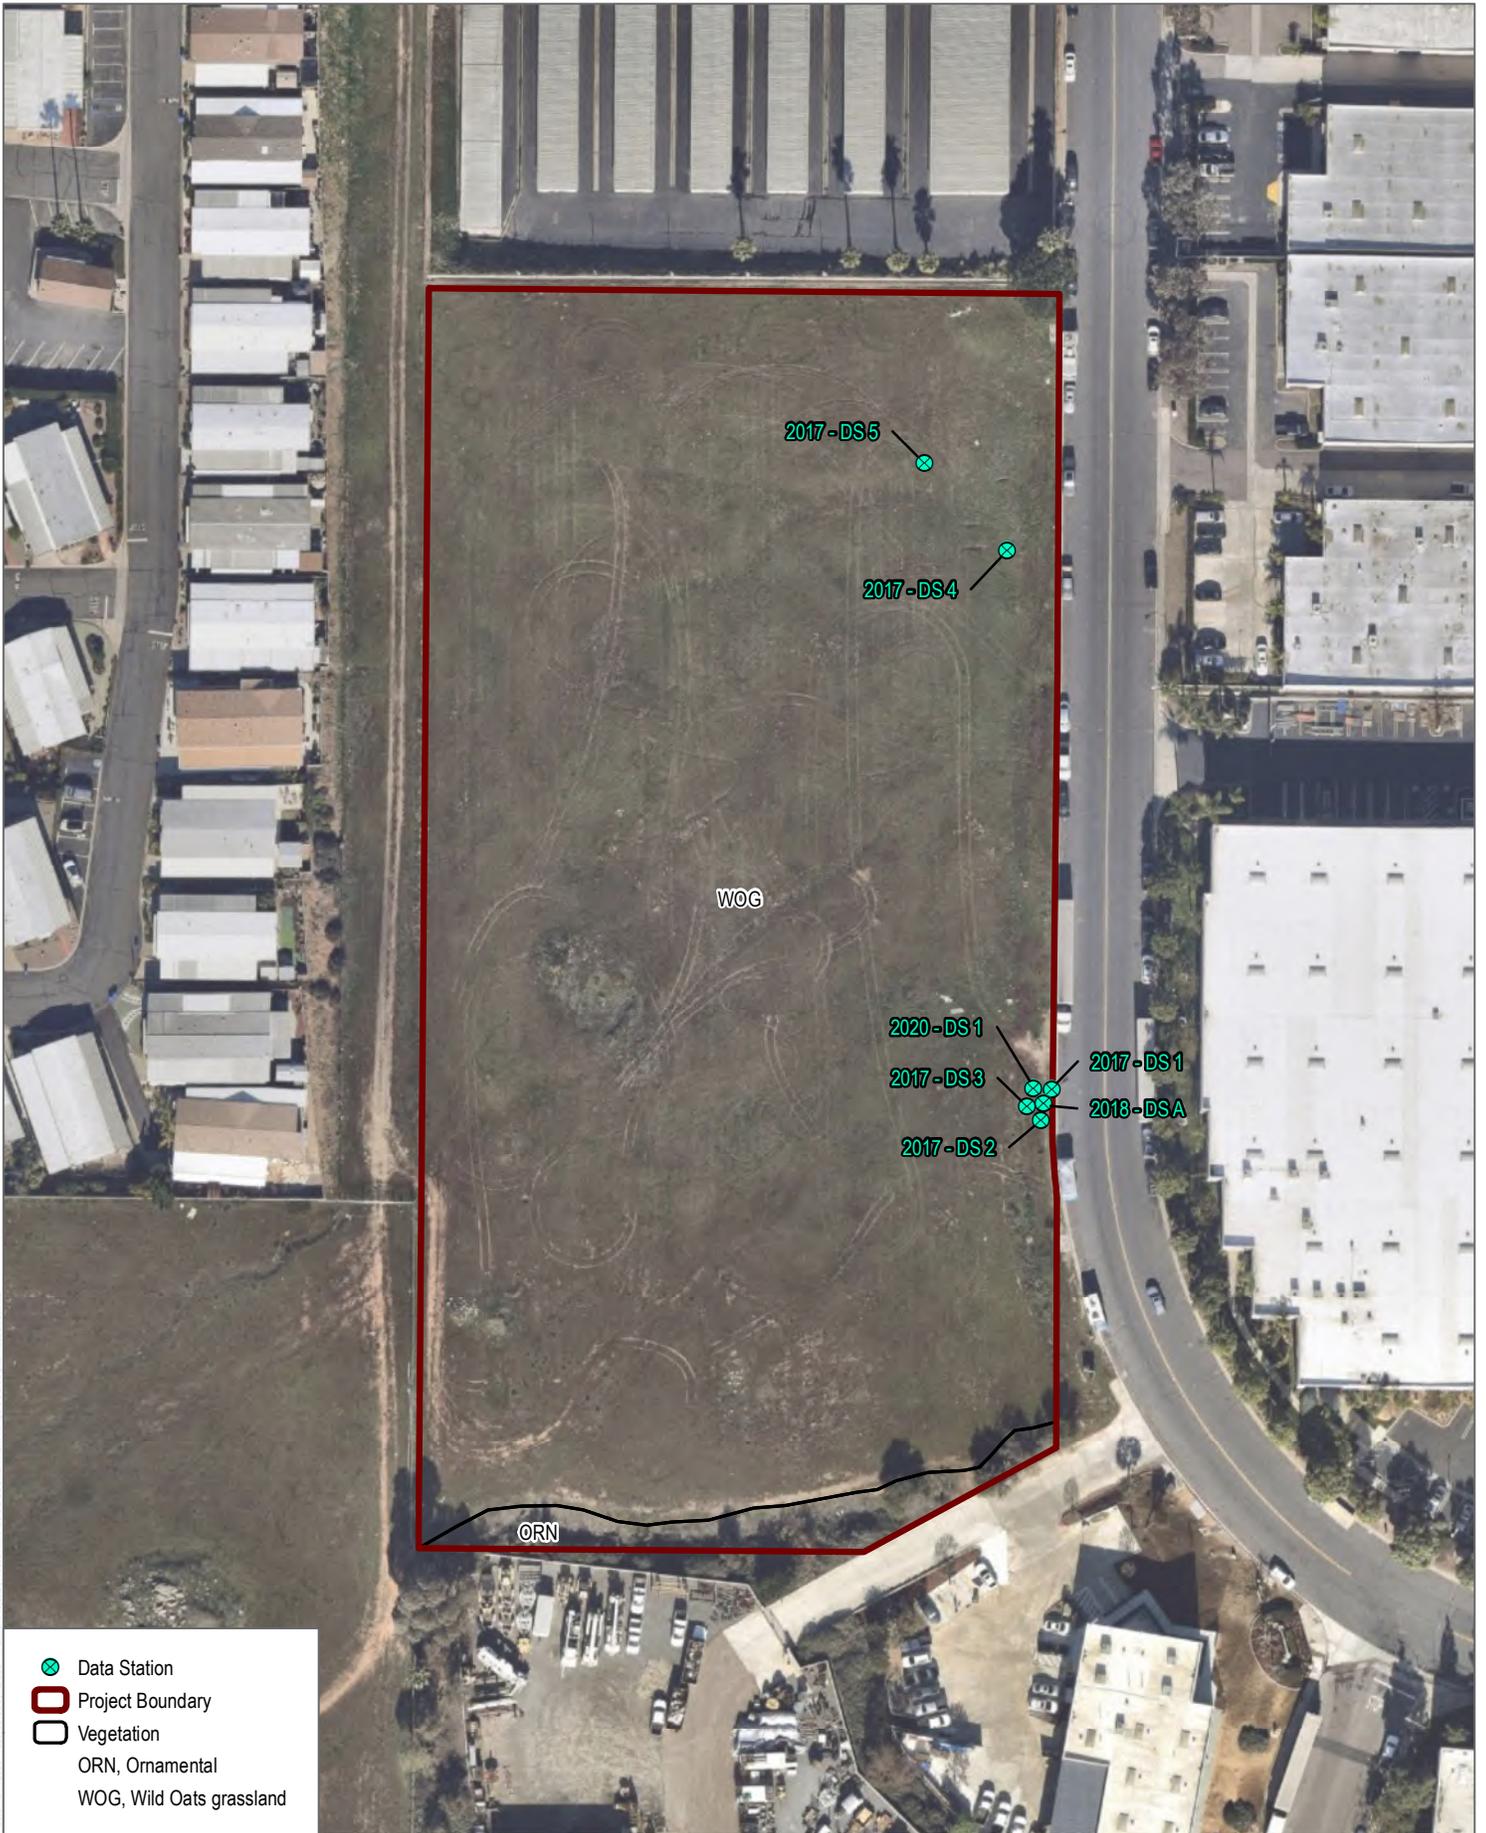
Biological Resources

- ✕ Data Station
- Project Boundary
- Vegetation
- ORN, Ornamental
- WOG, Wild Oats grassland

Vegetation mapping was conducted within the Project site in July 2017 in conjunction with the initial reconnaissance-level surveys for sensitive resources. Mapping was performed in the field through interpretation of field maps with a high-quality aerial photographic basemap. In 2020, Dudek revisited the site to verify the vegetation mapping reflected the current conditions.

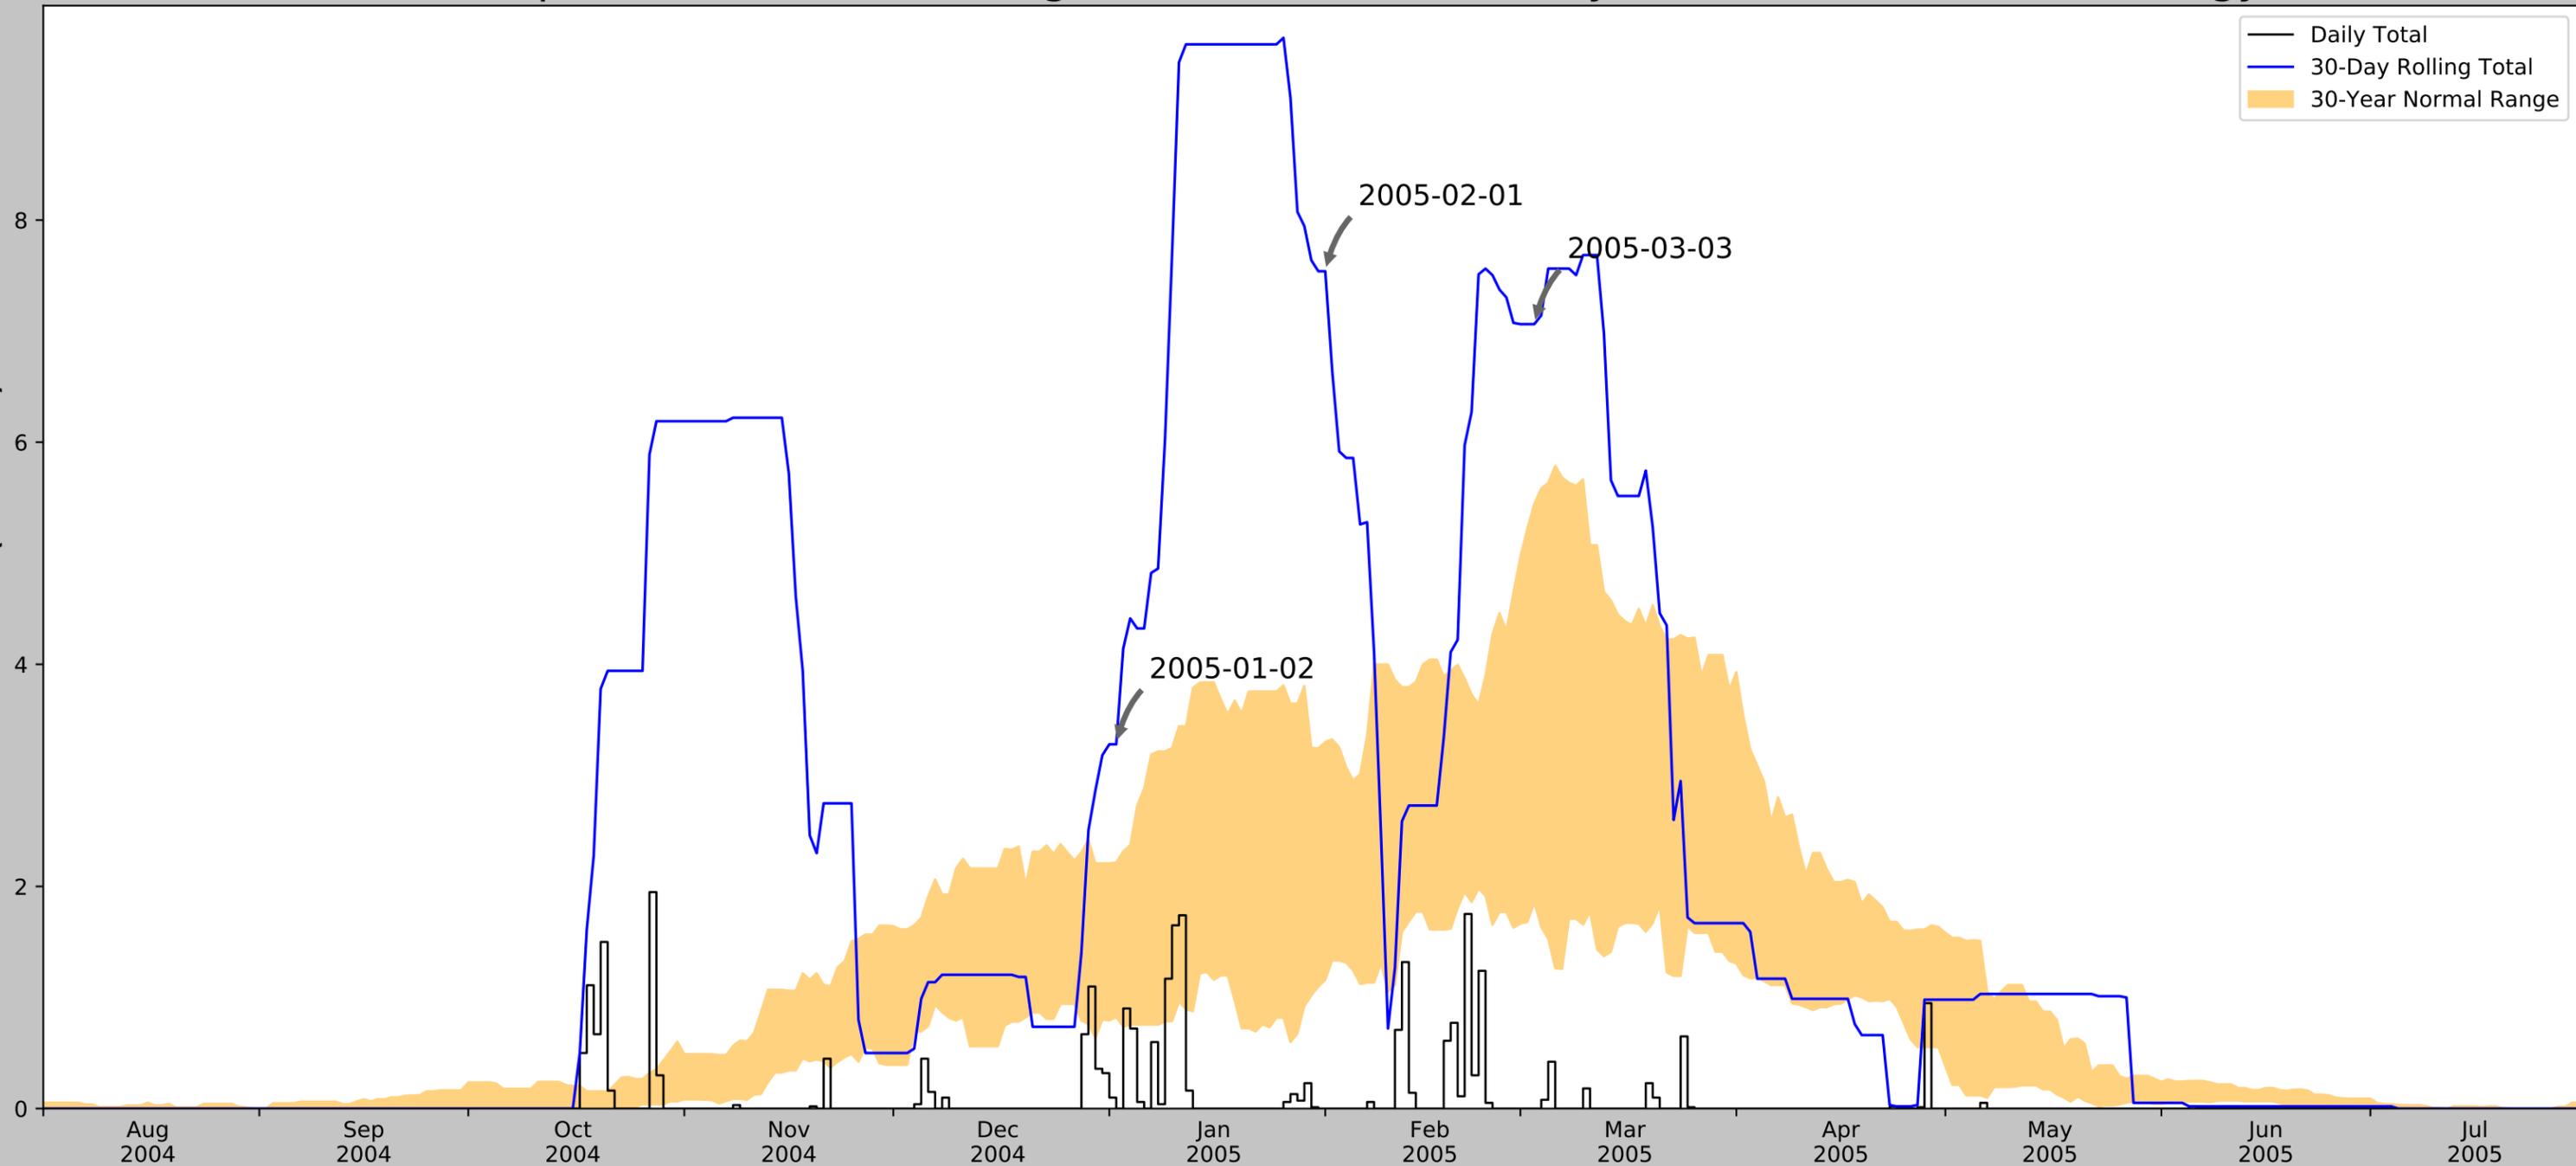
Antecedent Precipitation vs Normal Range based on NOAA's Daily Global Historical Climatology Network

Coordinates	33.130356, -117.129175
Observation Date	2005-03-03
Elevation (ft)	719.04
Drought Index (PDSI)	Extreme wetness
WebWIMP H ₂ O Balance	Wet Season

30 Days Ending	30 th %ile (in)	70 th %ile (in)	Observed (in)	Wetness Condition	Condition Value	Month Weight	Product
2005-03-03	1.854724	5.446063	7.062992	Wet	3	3	9
2005-02-01	1.15748	3.302756	7.53937	Wet	3	2	6
2005-01-02	0.822047	2.216929	3.279528	Wet	3	1	3
Result							Wetter than Normal - 18

To help provide context of the varying results at the site, Dudek analyzed each year’s delineation using the Antecedent Precipitation Tool (USACE 2020; Appendix E). As mentioned in Section 2, the winter of 2004/2005 was one of the wettest winters recorded in over 120 years (Kleinfelder 2007). The Antecedent Precipitation Tool shows that the 2005 delineation was done during a wetter than normal year, with extreme wetness compared to the 30-year normal range (Appendix E). This would explain why the features observed in 2005 that have not been observed since: the conditions did not reflect a normal range of precipitation in the region. Kleinfelder (2007) also notes that REC may have had a false positive for hydrology and vegetation due to a wetter than normal winter. In 2007, the rainfall was drier than normal, but still fell within the 30-year normal range. However, the field investigation on February 22, 2007 occurred after two recent rain events, providing wet conditions on site. The investigations done in 2017, 2018, and 2020 were done during normal conditions (Appendix E).

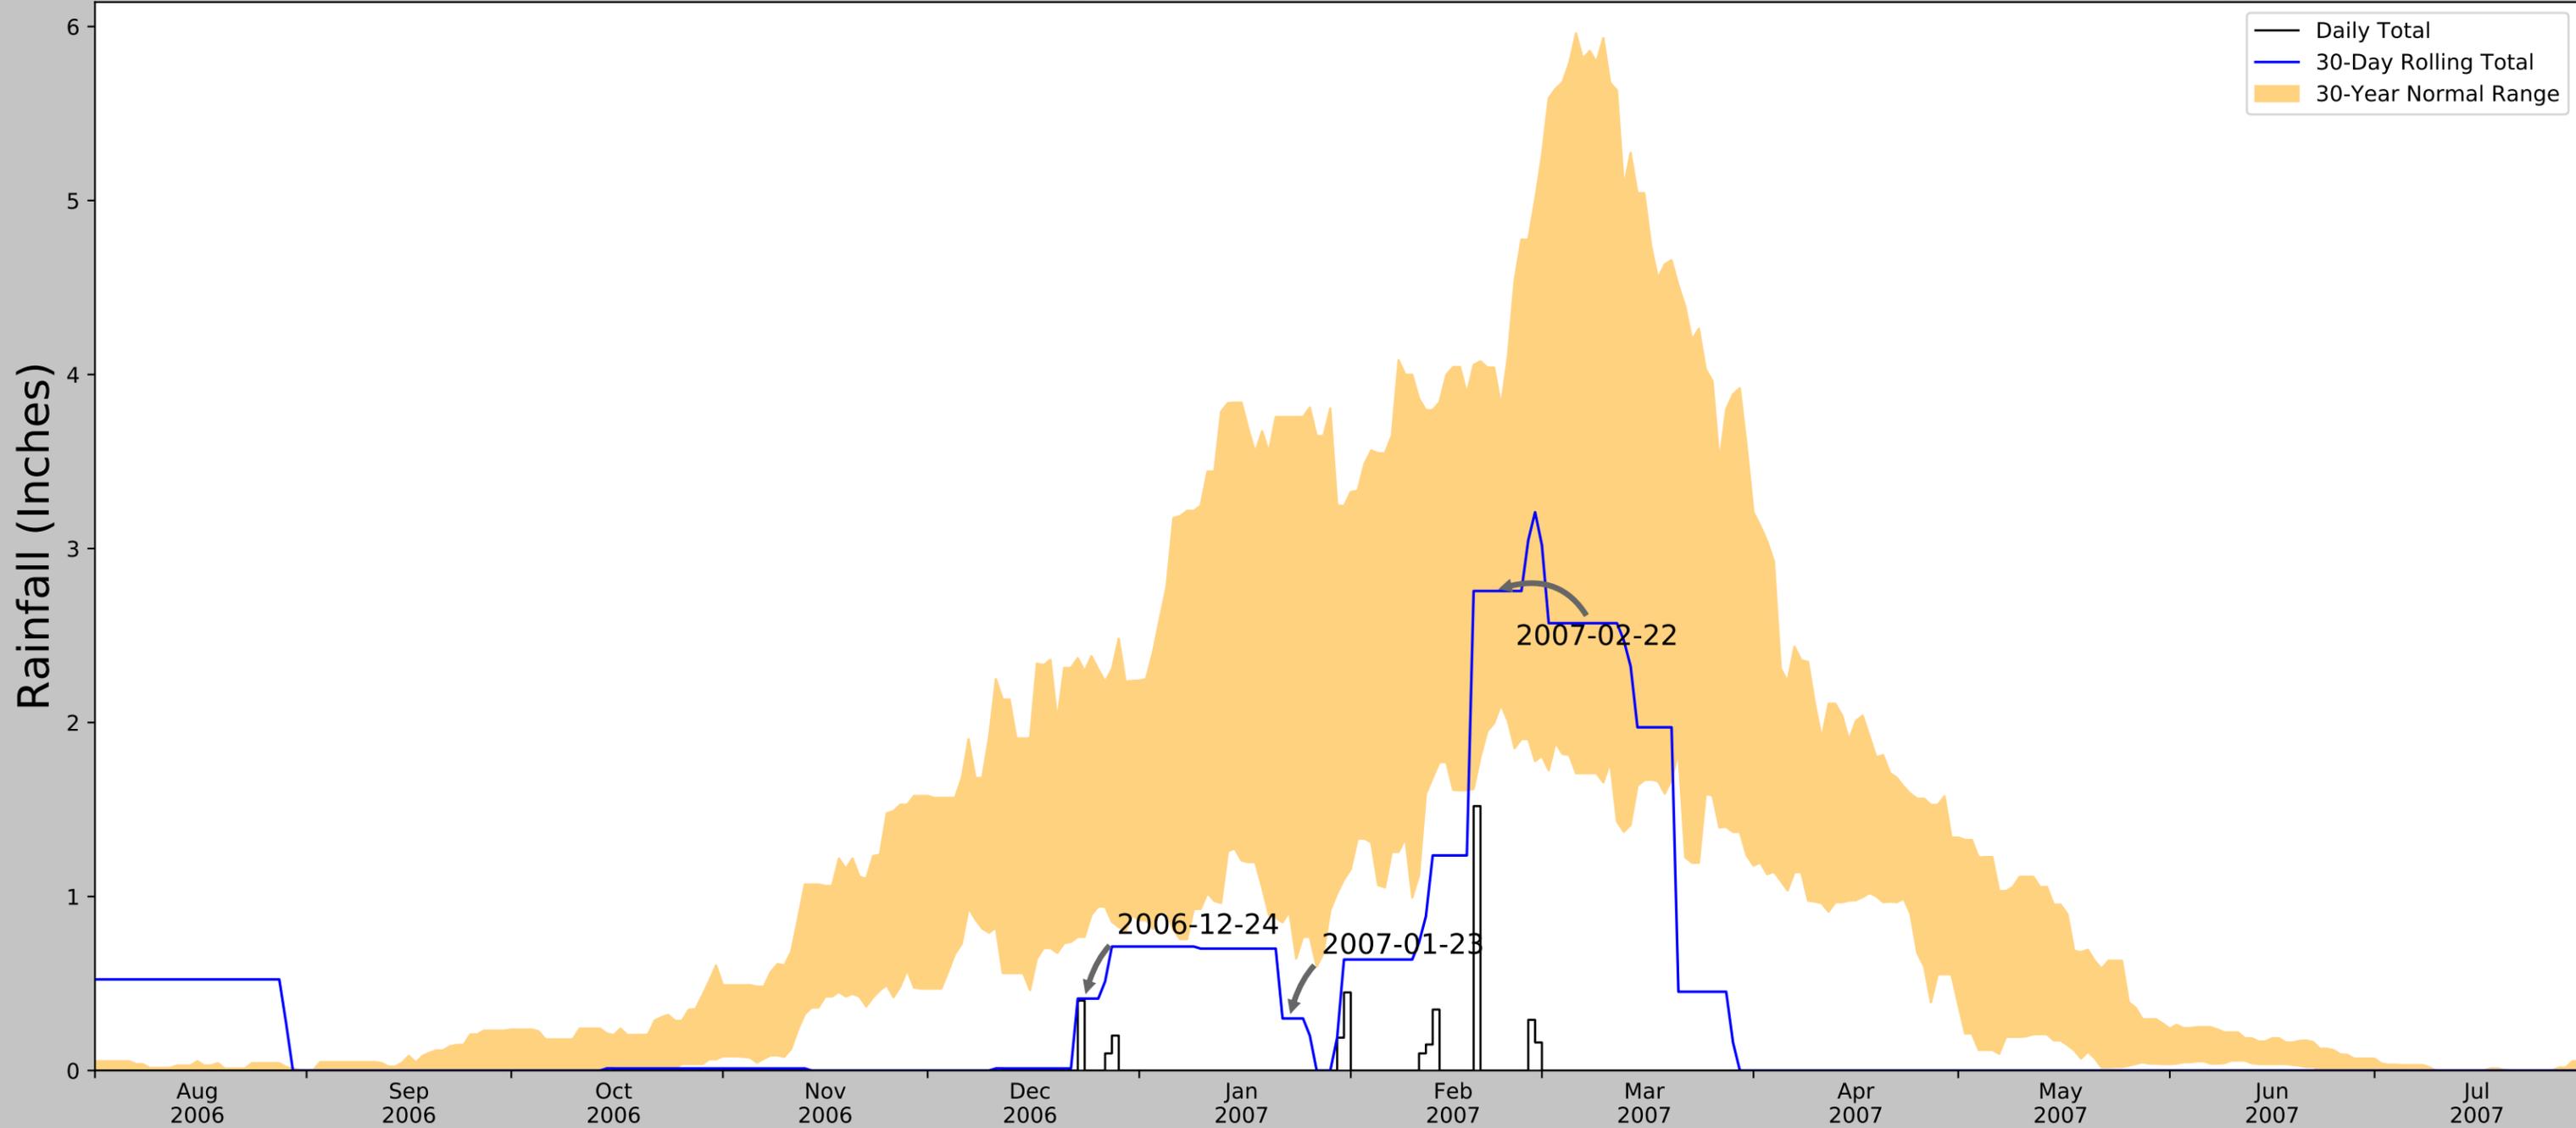
Antecedent Precipitation vs Normal Range based on NOAA's Daily Global Historical Climatology Network

Coordinates	33.130356, -117.129175
Observation Date	2007-02-22
Elevation (ft)	719.04
Drought Index (PDSI)	Severe drought
WebWIMP H ₂ O Balance	Wet Season

30 Days Ending	30 th %ile (in)	70 th %ile (in)	Observed (in)	Wetness Condition	Condition Value	Month Weight	Product
2007-02-22	1.996457	4.040551	2.755906	Normal	2	3	6
2007-01-23	0.91378	3.755906	0.299213	Dry	1	2	2
2006-12-24	0.767717	2.294882	0.413386	Dry	1	1	1
Result							Drier than Normal - 9

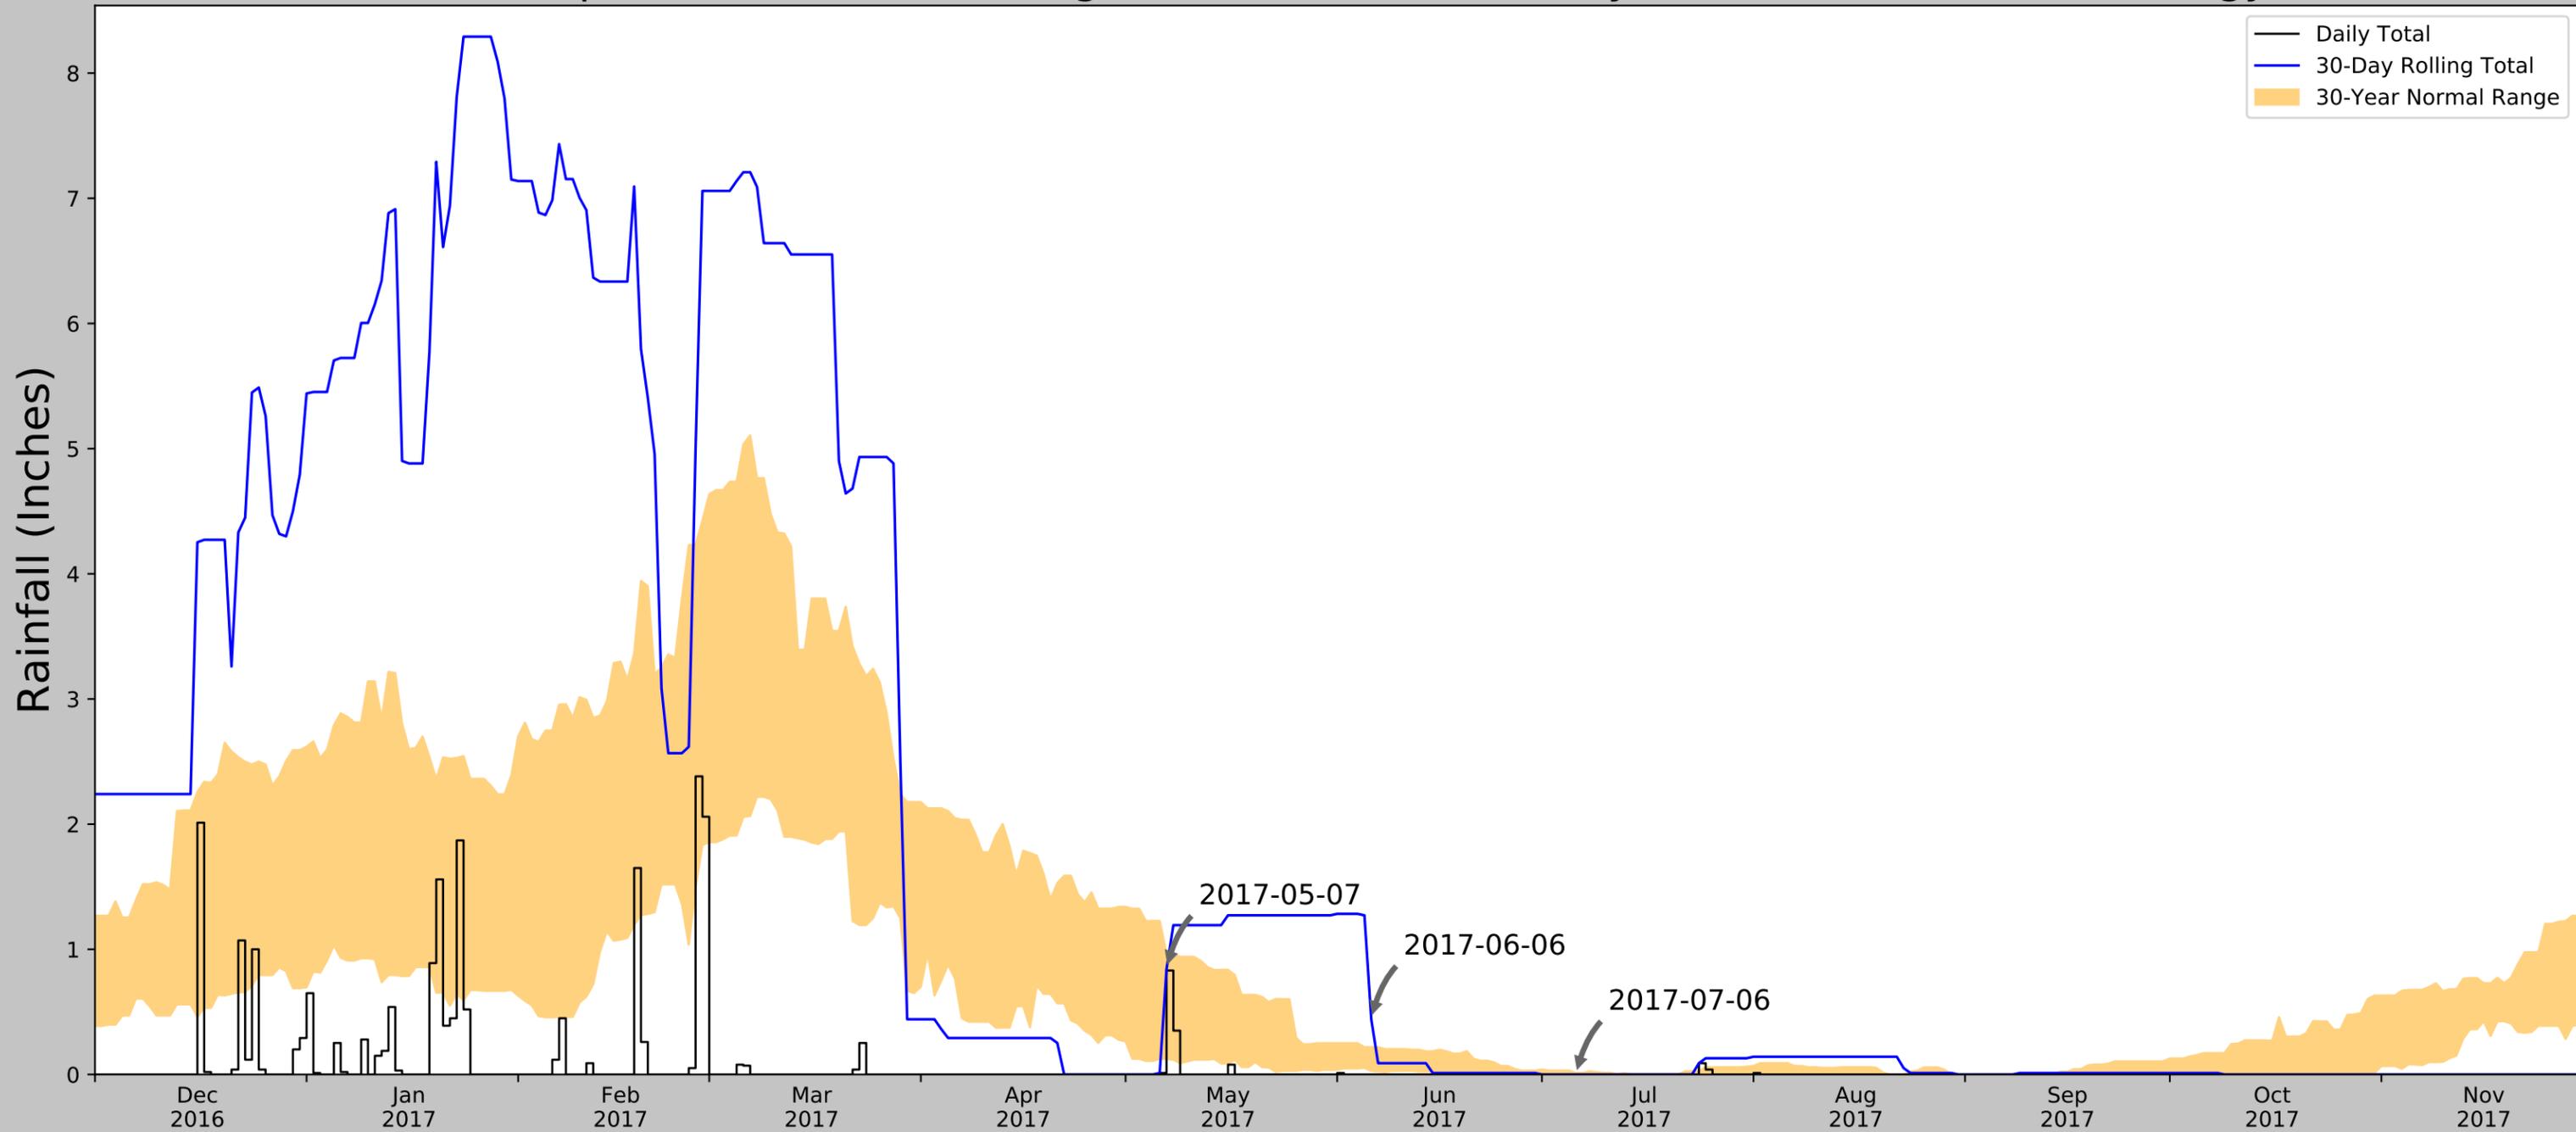
Antecedent Precipitation vs Normal Range based on NOAA's Daily Global Historical Climatology Network

Coordinates	33.130356, -117.129175
Observation Date	2017-07-06
Elevation (ft)	719.04
Drought Index (PDSI)	Moderate drought
WebWIMP H ₂ O Balance	Dry Season

30 Days Ending	30 th %ile (in)	70 th %ile (in)	Observed (in)	Wetness Condition	Condition Value	Month Weight	Product
2017-07-06	0.0	0.011811	0.0	Normal	2	3	6
2017-06-06	0.027953	0.21811	0.440945	Wet	3	2	6
2017-05-07	0.125197	0.96811	0.84252	Normal	2	1	2
Result							Normal Conditions - 14

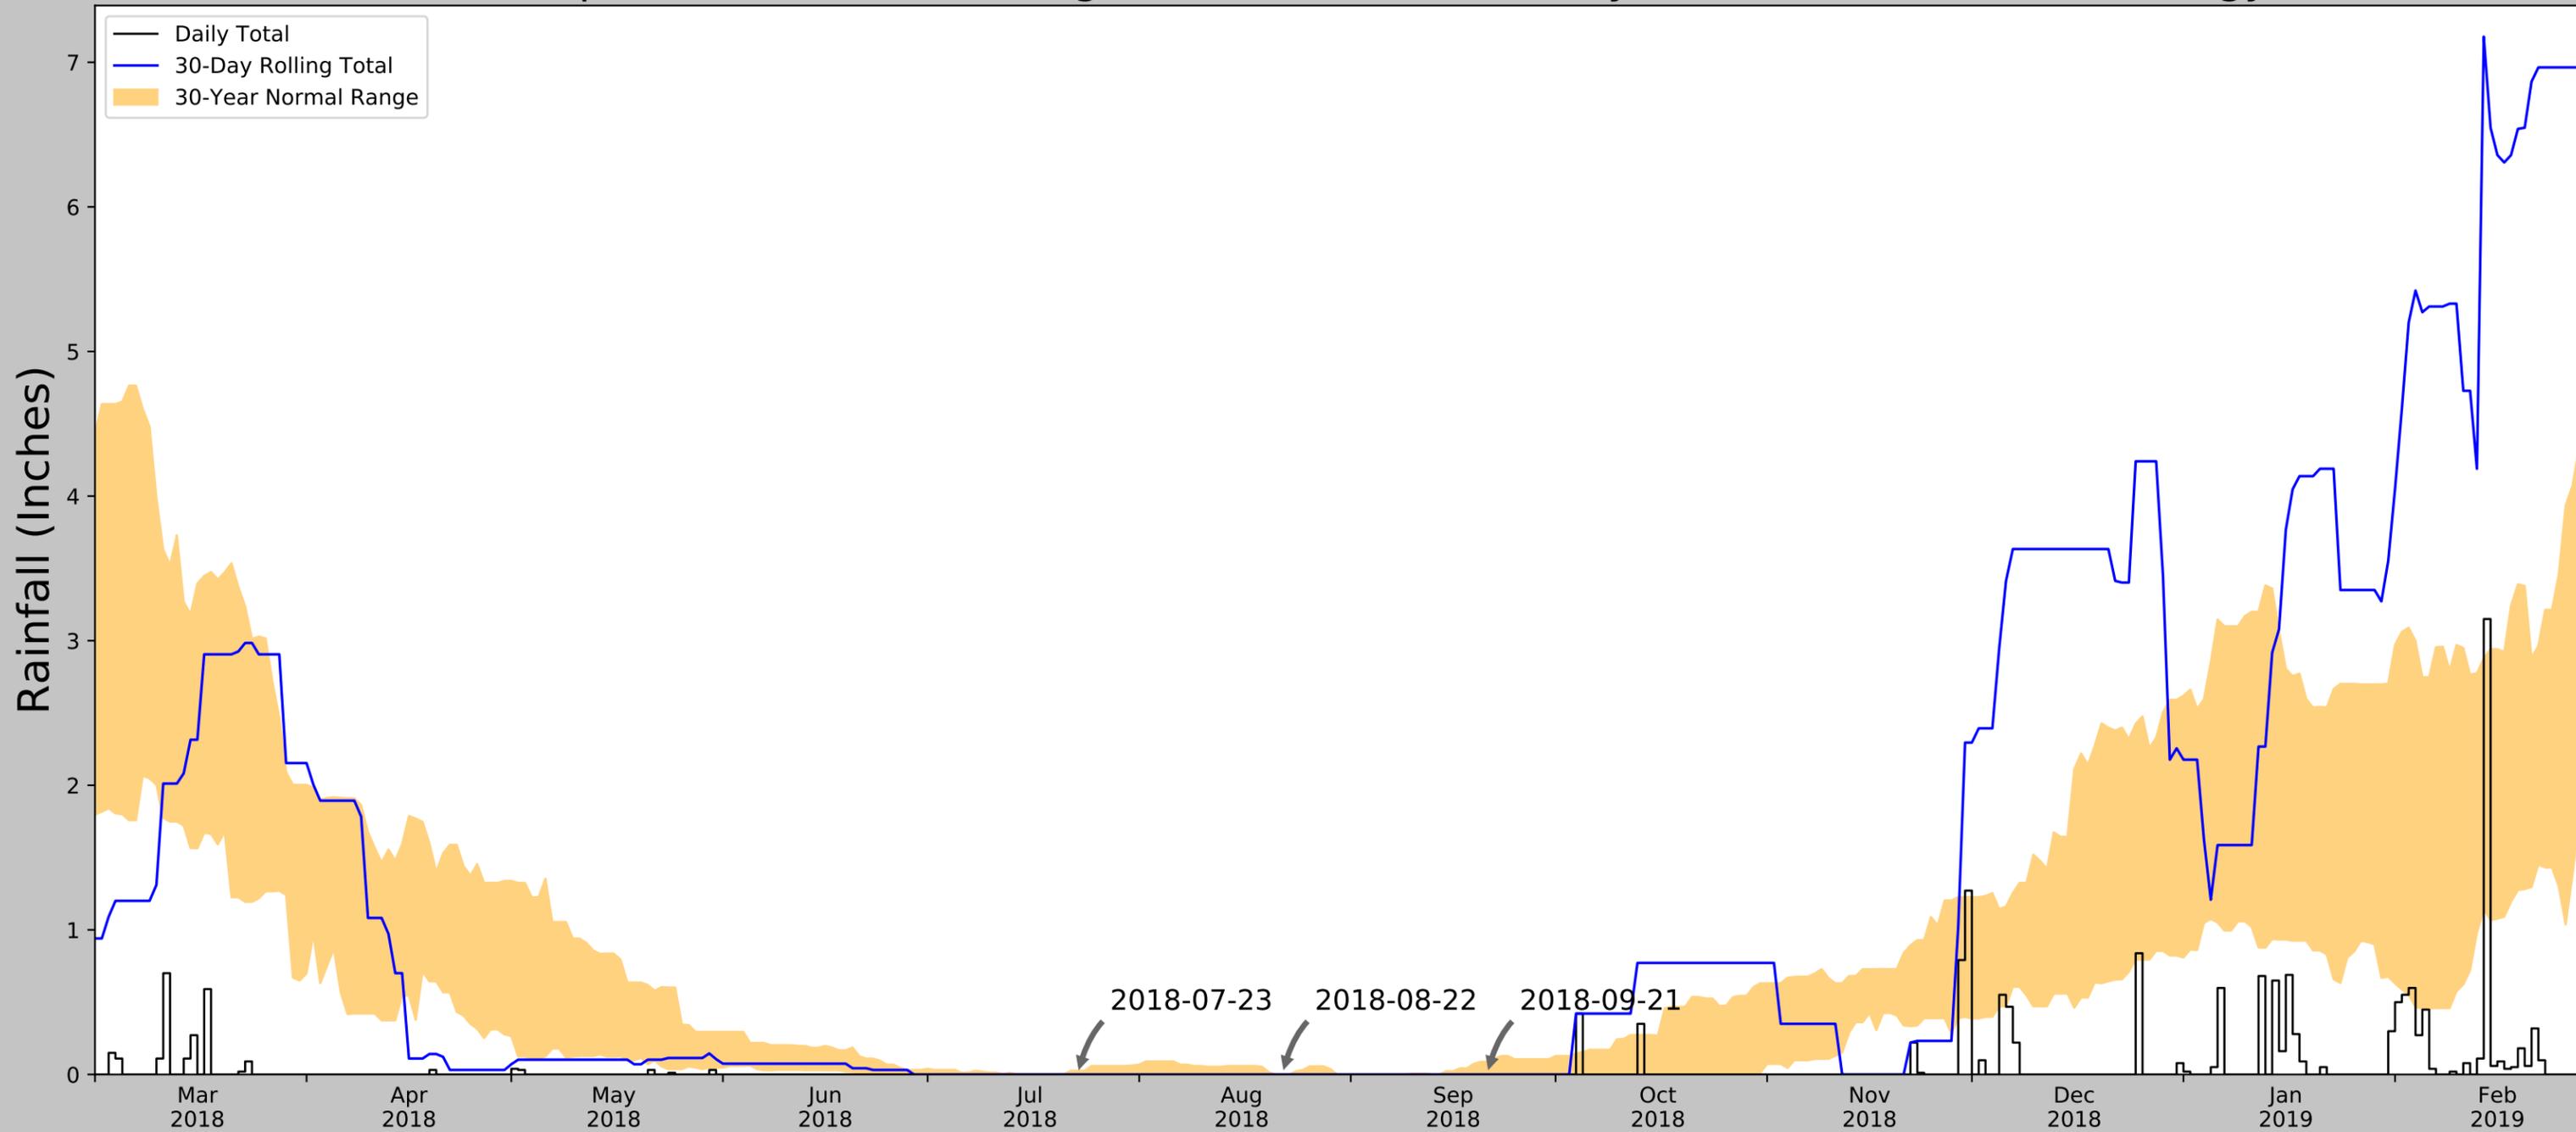
Antecedent Precipitation vs Normal Range based on NOAA's Daily Global Historical Climatology Network

Coordinates	33.130356, -117.129175
Observation Date	2018-09-21
Elevation (ft)	719.04
Drought Index (PDSI)	Extreme drought
WebWIMP H ₂ O Balance	Dry Season

30 Days Ending	30 th %ile (in)	70 th %ile (in)	Observed (in)	Wetness Condition	Condition Value	Month Weight	Product
2018-09-21	0.0	0.087402	0.0	Normal	2	3	6
2018-08-22	0.0	0.0	0.0	Normal	2	2	4
2018-07-23	0.0	0.025984	0.0	Normal	2	1	2
Result							Normal Conditions - 12

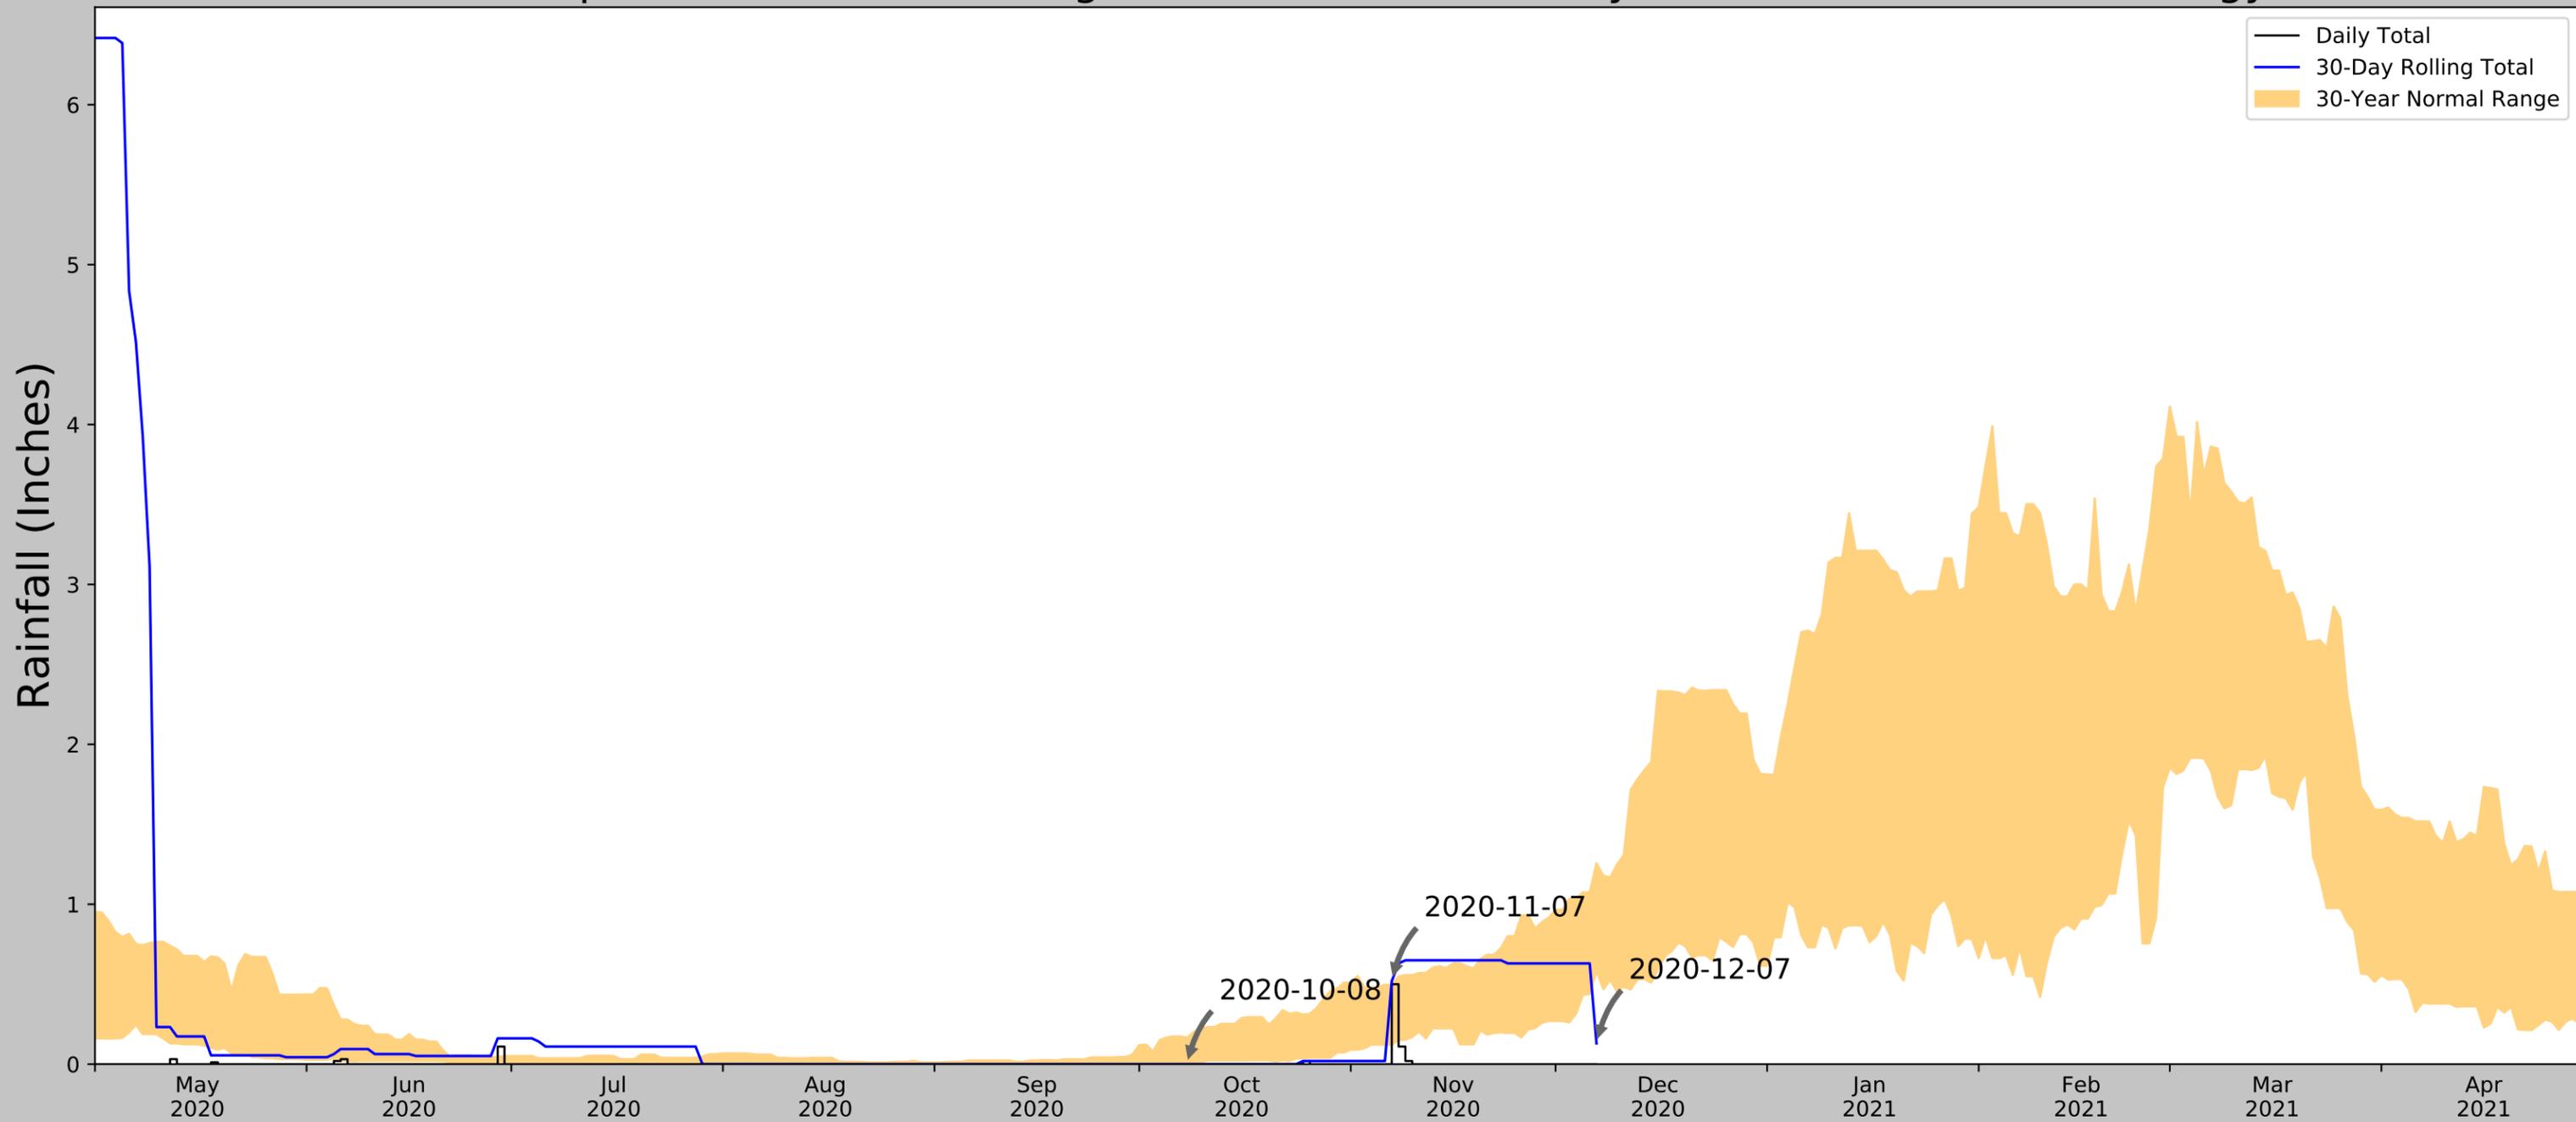
Antecedent Precipitation vs Normal Range based on NOAA's Daily Global Historical Climatology Network

Coordinates	33.130356, -117.129175
Observation Date	2020-12-07
Elevation (ft)	719.04
Drought Index (PDSI)	Mild drought (2020-11)
WebWIMP H ₂ O Balance	Wet Season

30 Days Ending	30 th %ile (in)	70 th %ile (in)	Observed (in)	Wetness Condition	Condition Value	Month Weight	Product
2020-12-07	0.581496	1.25748	0.129921	Dry	1	3	3
2020-11-07	0.121654	0.496457	0.519685	Wet	3	2	6
2020-10-08	0.008268	0.165748	0.0	Dry	1	1	1
Result							Normal Conditions - 10
