Final Initial Study

Chalice Unitarian Universalist Congregation Conditional Use Permit

Appendix A Chalice Unitarian Universalist Congregation Biological Resources Memorandum

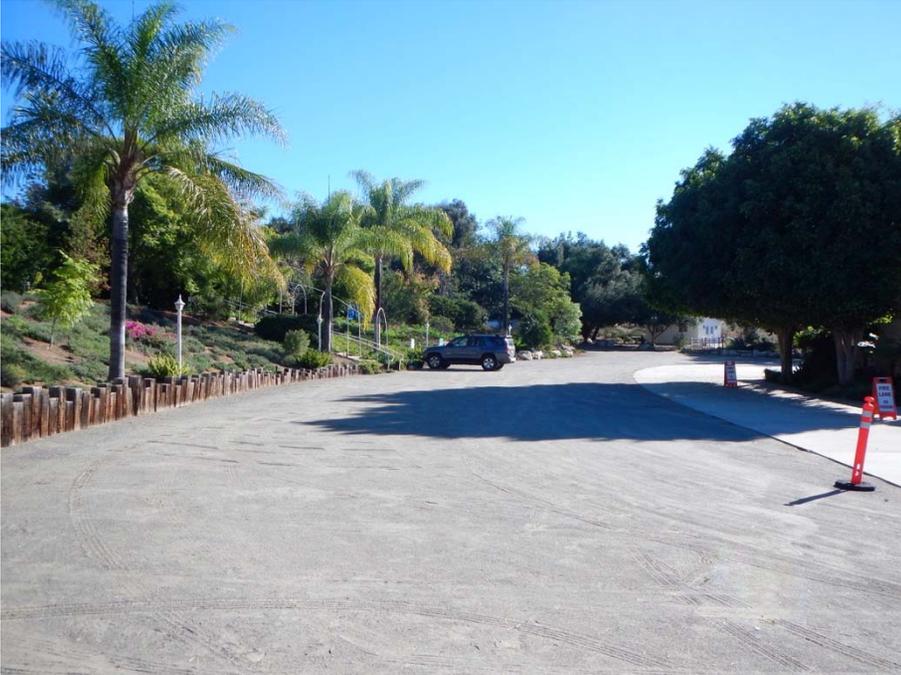
Photograph # 1

Existing lower, main parking lot, facing northeast.

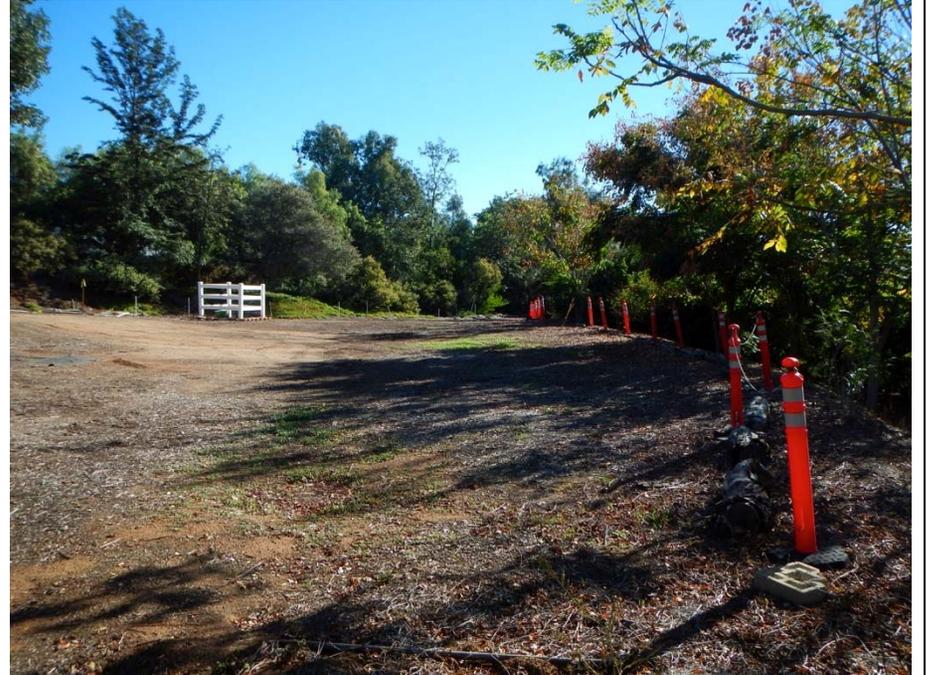
Photograph # 2

Disturbed habitat within upper parking area, facing northeast.

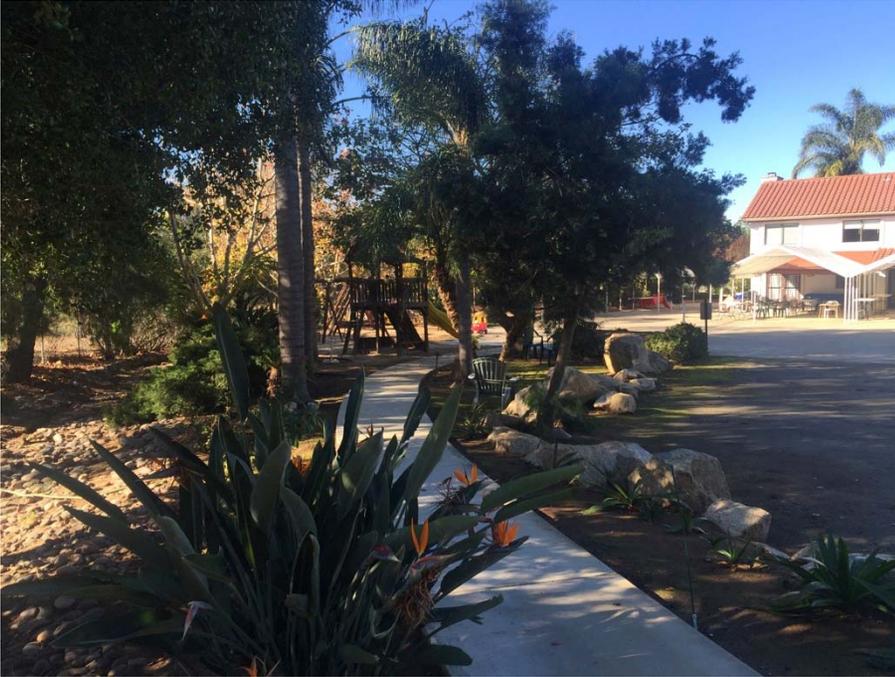
Photograph # 3

Area of future stormwater detention basin on right and multi-purpose building in background, facing southwest.

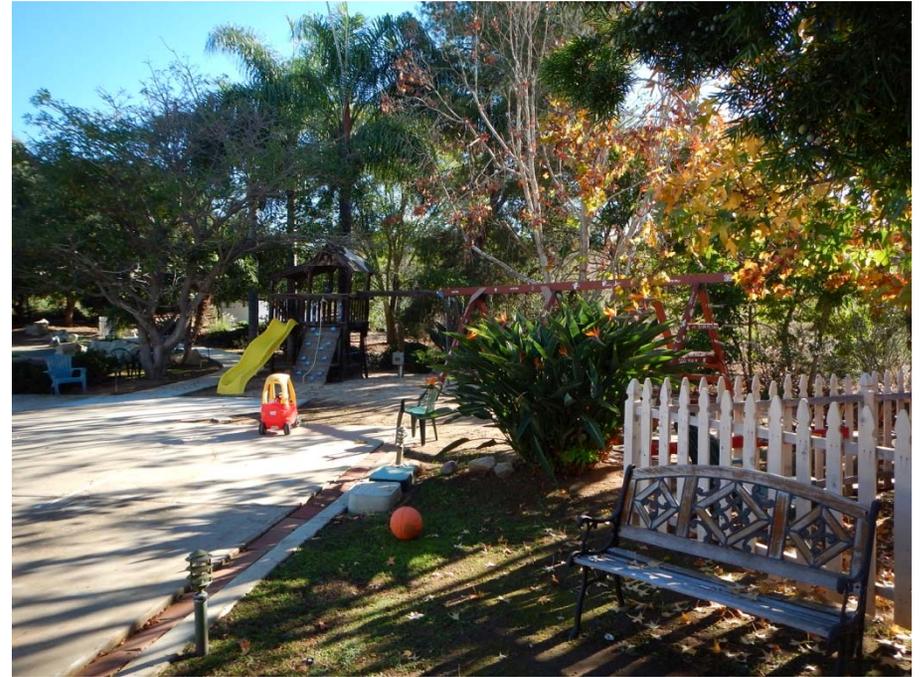
Photograph # 4

Future area of multi-purpose building, facing northeast.

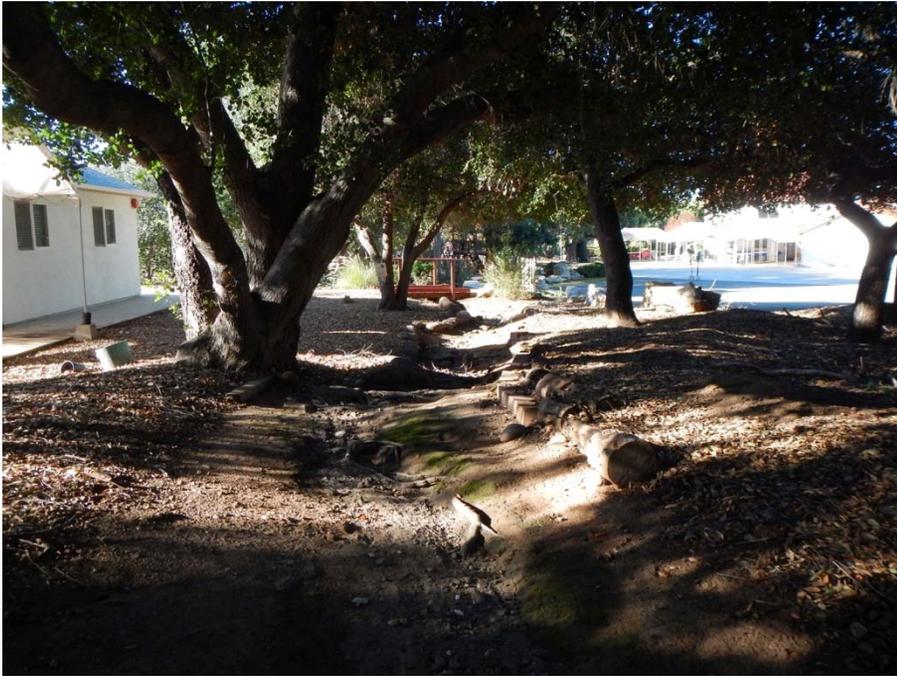
Photograph # 5

No potentially jurisdictional features will be impacted as a result of the proposed construction activities. The existing drainage swale, as mentioned above, runs through the eastern edge of the property through the disturbed coast live oak woodland and presumably contains water during and immediately after significant rain events for short durations of time. The ephemeral water enters the property along the northeastern property line from an existing culvert that runs underneath Interstate-15. The northern portion of the water feature is best characterized as a natural swale. Moving southward, the swale contains imported river rock and eventually becomes a concrete brow ditch channel. The channel exits the property in the southeast corner and flows underneath Hamilton Lane through a culvert, exiting to a previously determined one foot wide Non-wetland Waters of the U.S. and Waters of the State (Helix Environmental, Oak Creek Project, 2014). The proposed construction activities have been designed to avoid altering the flow, topography, and/or adding fill material to the existing swale.

Existing swale water feature at northern property boundary, facing southwest.

- Construction activities are not expected to alter the topography, flow, or result in additional discharge to the drainage swale; therefore, it is expected no significant impacts will occur as a result of the proposed construction activities.
- It is recommended that appropriate erosion and sedimentation controls be implemented during construction in order to prevent potential adverse water quality impacts to the drainage swale.

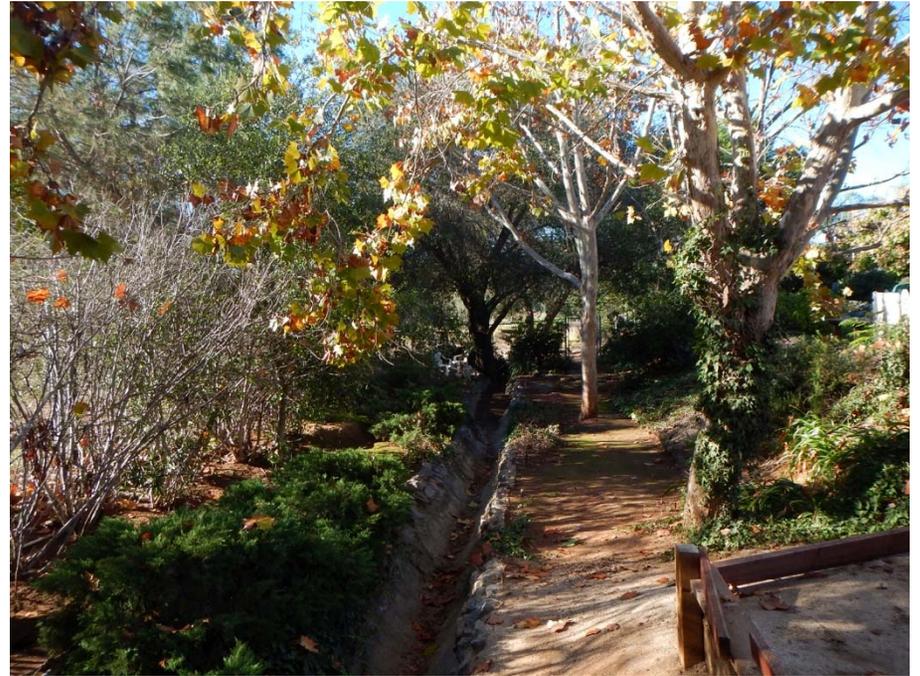
Photograph # 6

Concrete brow ditch water feature towards southern end of disturbed coast live oak woodland habitat, facing southwest.

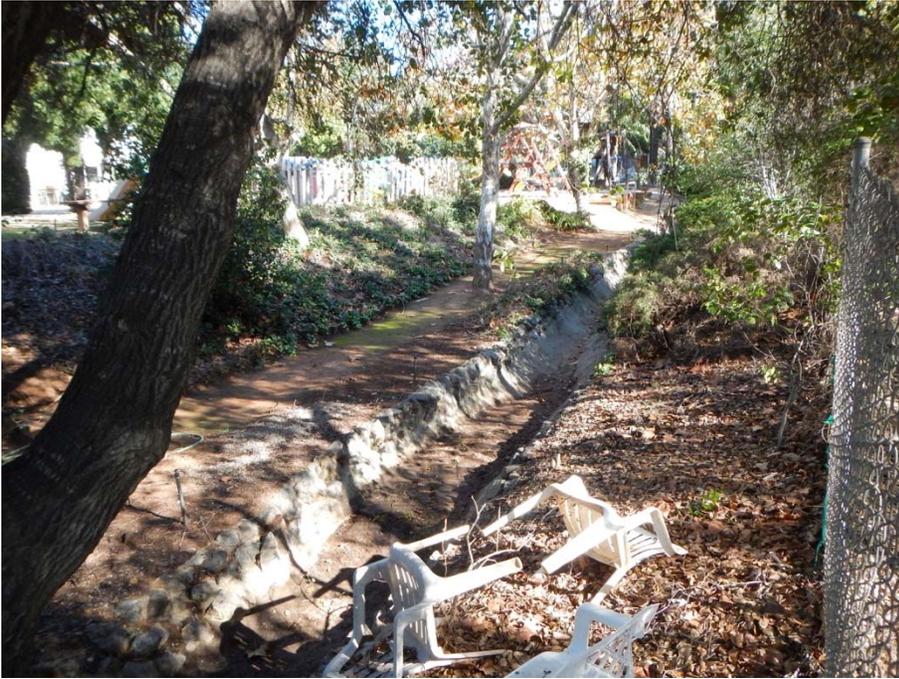
Photograph # 7

Concrete brow ditch with future multi-purpose building in background, facing north.

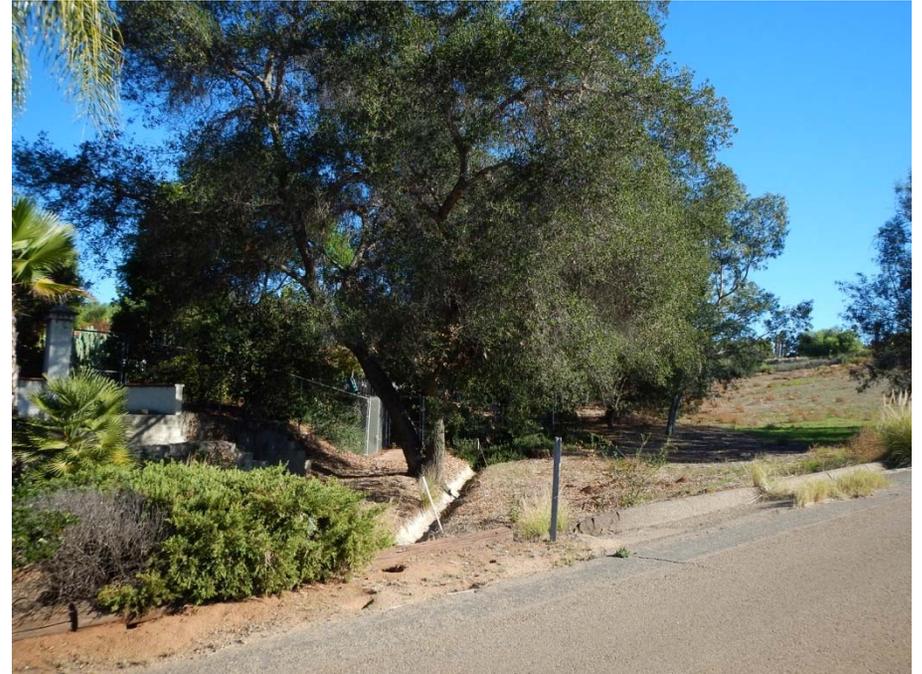
Photograph # 8

Concrete brow ditch exiting the southeastern property line, subsequently crossing underneath Hamilton Lane, facing northeast.
