SUBJECT: Results of Vegetation Mapping for Latitude II, Escondido, California

**LATITUDE II PROJECT**  
 Vegetation Map

**PROJECT NUMBER:** 10870002  
**TO:** Peter Zak  
**FROM:** Tony Bomkamp  
**DATE:** February 2, 2015  
**SUBJECT:** Latitude II Project Biological Survey and Wetland Determination Results

SUBJECT: Jurisdictional Determination for Latitude II, Escondido, California

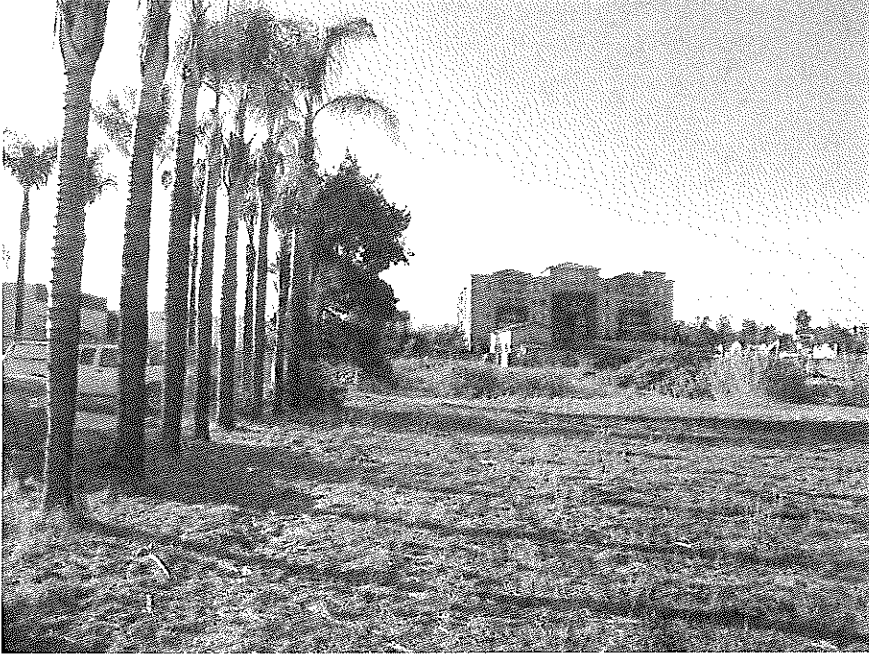
Photograph 1: Photo depicts sparse, annual brome grasslands in the eastern portion of the site.

Approximately 0.39 acres of the Project site located in the eastern and north western open areas are vegetated with annual brome grasslands alliance. The annual brome grasslands alliance vegetation type has no rank, meaning it is not threatened in either a local or global capacity. It should also be noted that annual brome grasslands are non-native and invasive.

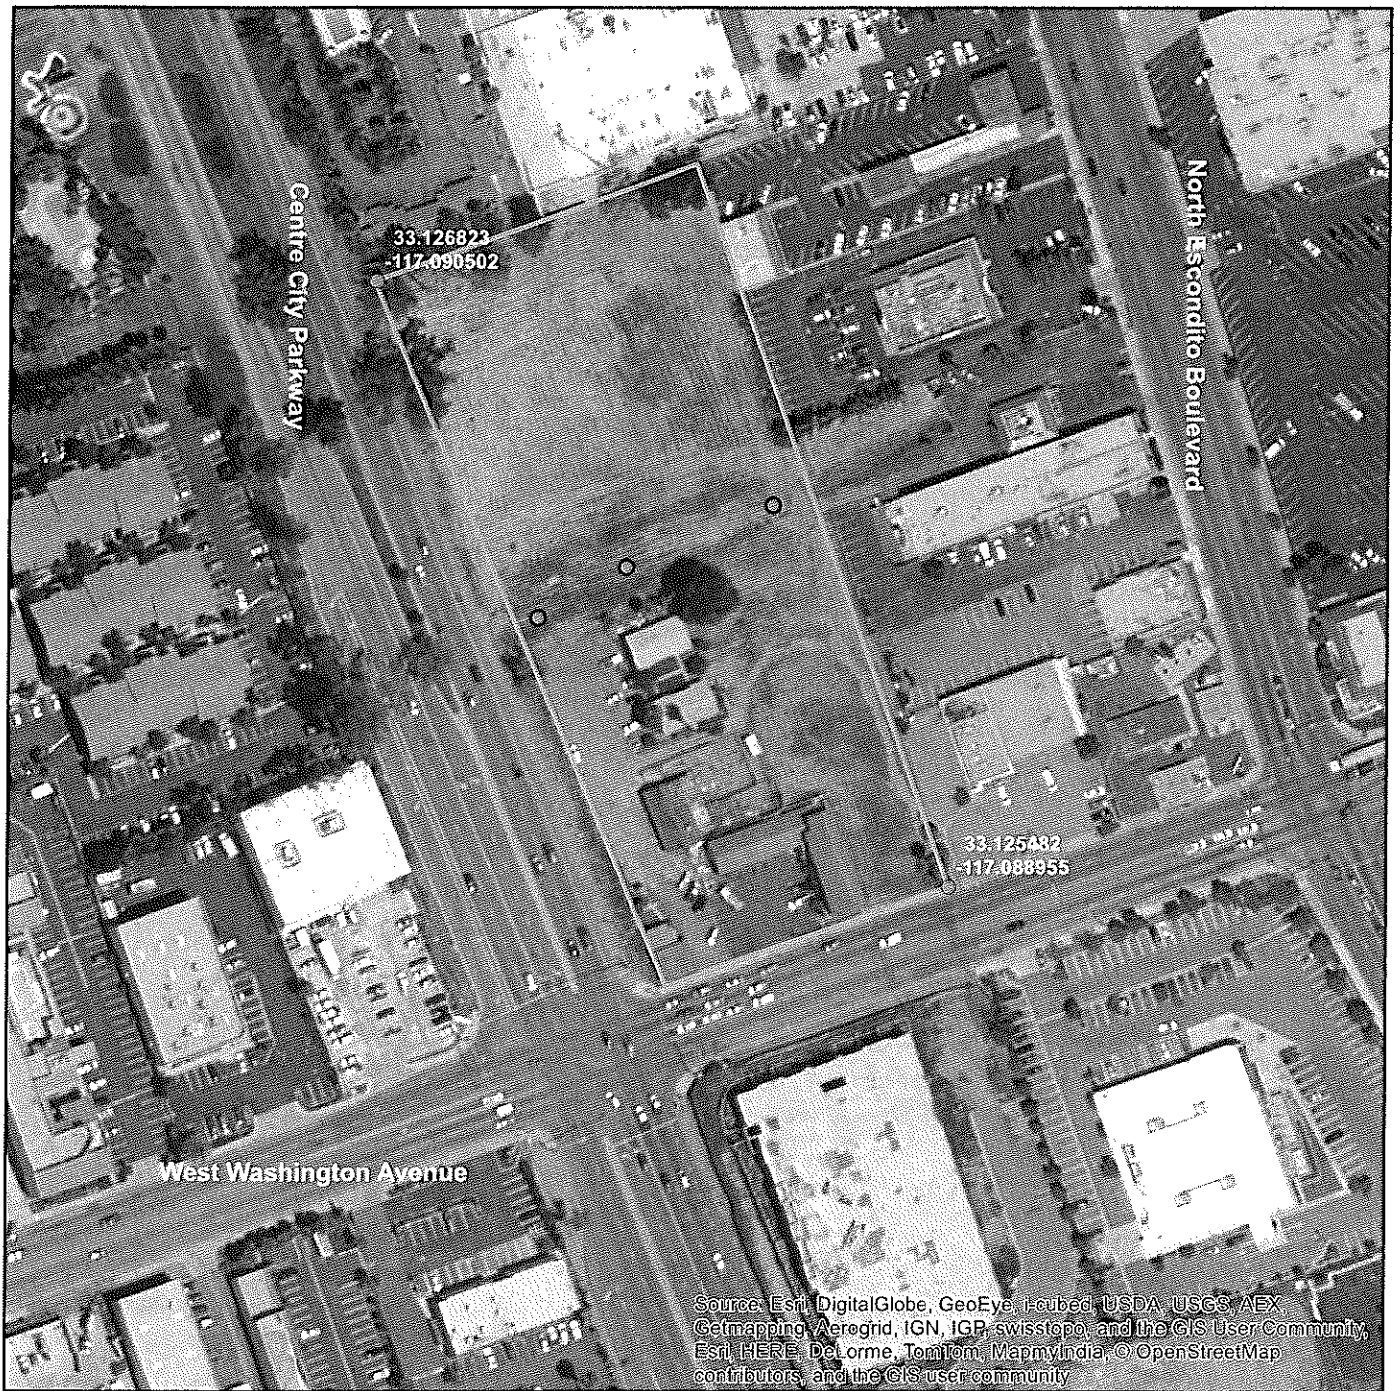
The plants were examined at three data collection points, [Exhibit 3] with each one failing the basic dominance test. The prevalence index score from point 1 is 3.89, with soil point 2 scoring 3.59, and point 3 scoring 3.87. Given that all three points failed both the basic dominance test and the prevalence index, the site does not support hydrophytic vegetation.

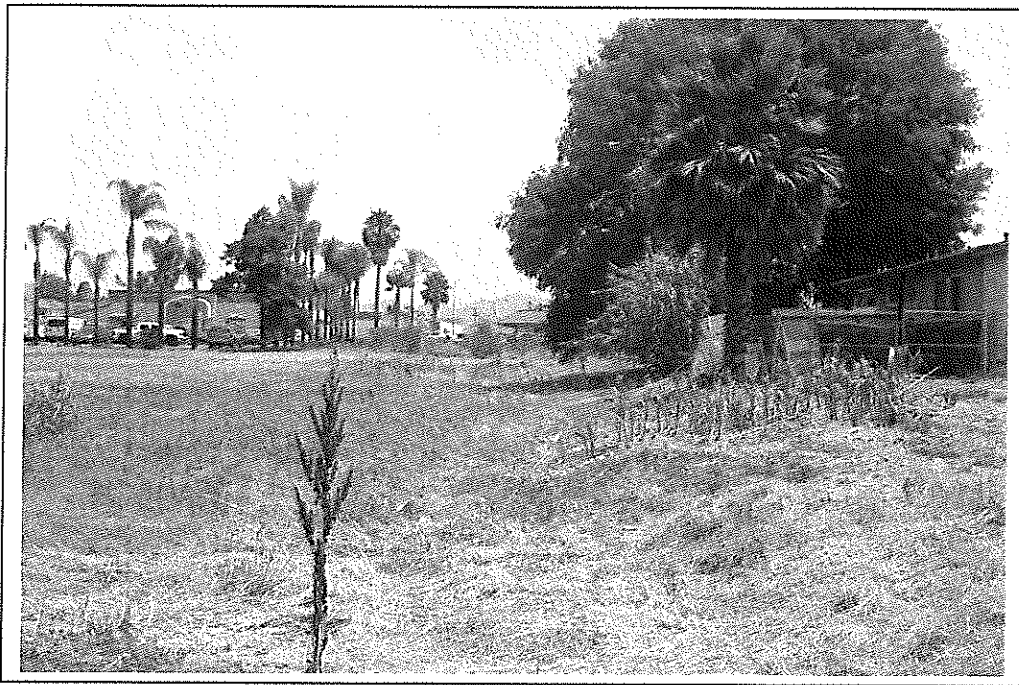
The project site contains a single swale that enters the site at the eastern boundary and extends in a westerly direction to a concrete inlet where it exits the site. The swale contains no indicators for an OHWM; rather it exhibits dense upland vegetation across the entire feature. The swale contains no wetlands.

Photograph 2: View of Swale Looking East
