# WAL-MART/ESCONDIDO UNION SCHOOL DISTRICT PLANNED DEVELOPMENT PROJECT

## Appendixes to the Final Environmental Impact Report

**APPENDIXES TO THE  
FINAL  
ENVIRONMENTAL IMPACT REPORT  
FOR THE  
WAL-MART/ESCONDIDO UNION SCHOOL DISTRICT  
PLANNED DEVELOPMENT PROJECT**

**SCH# 2003091029  
City Case No. ER 2003-01**

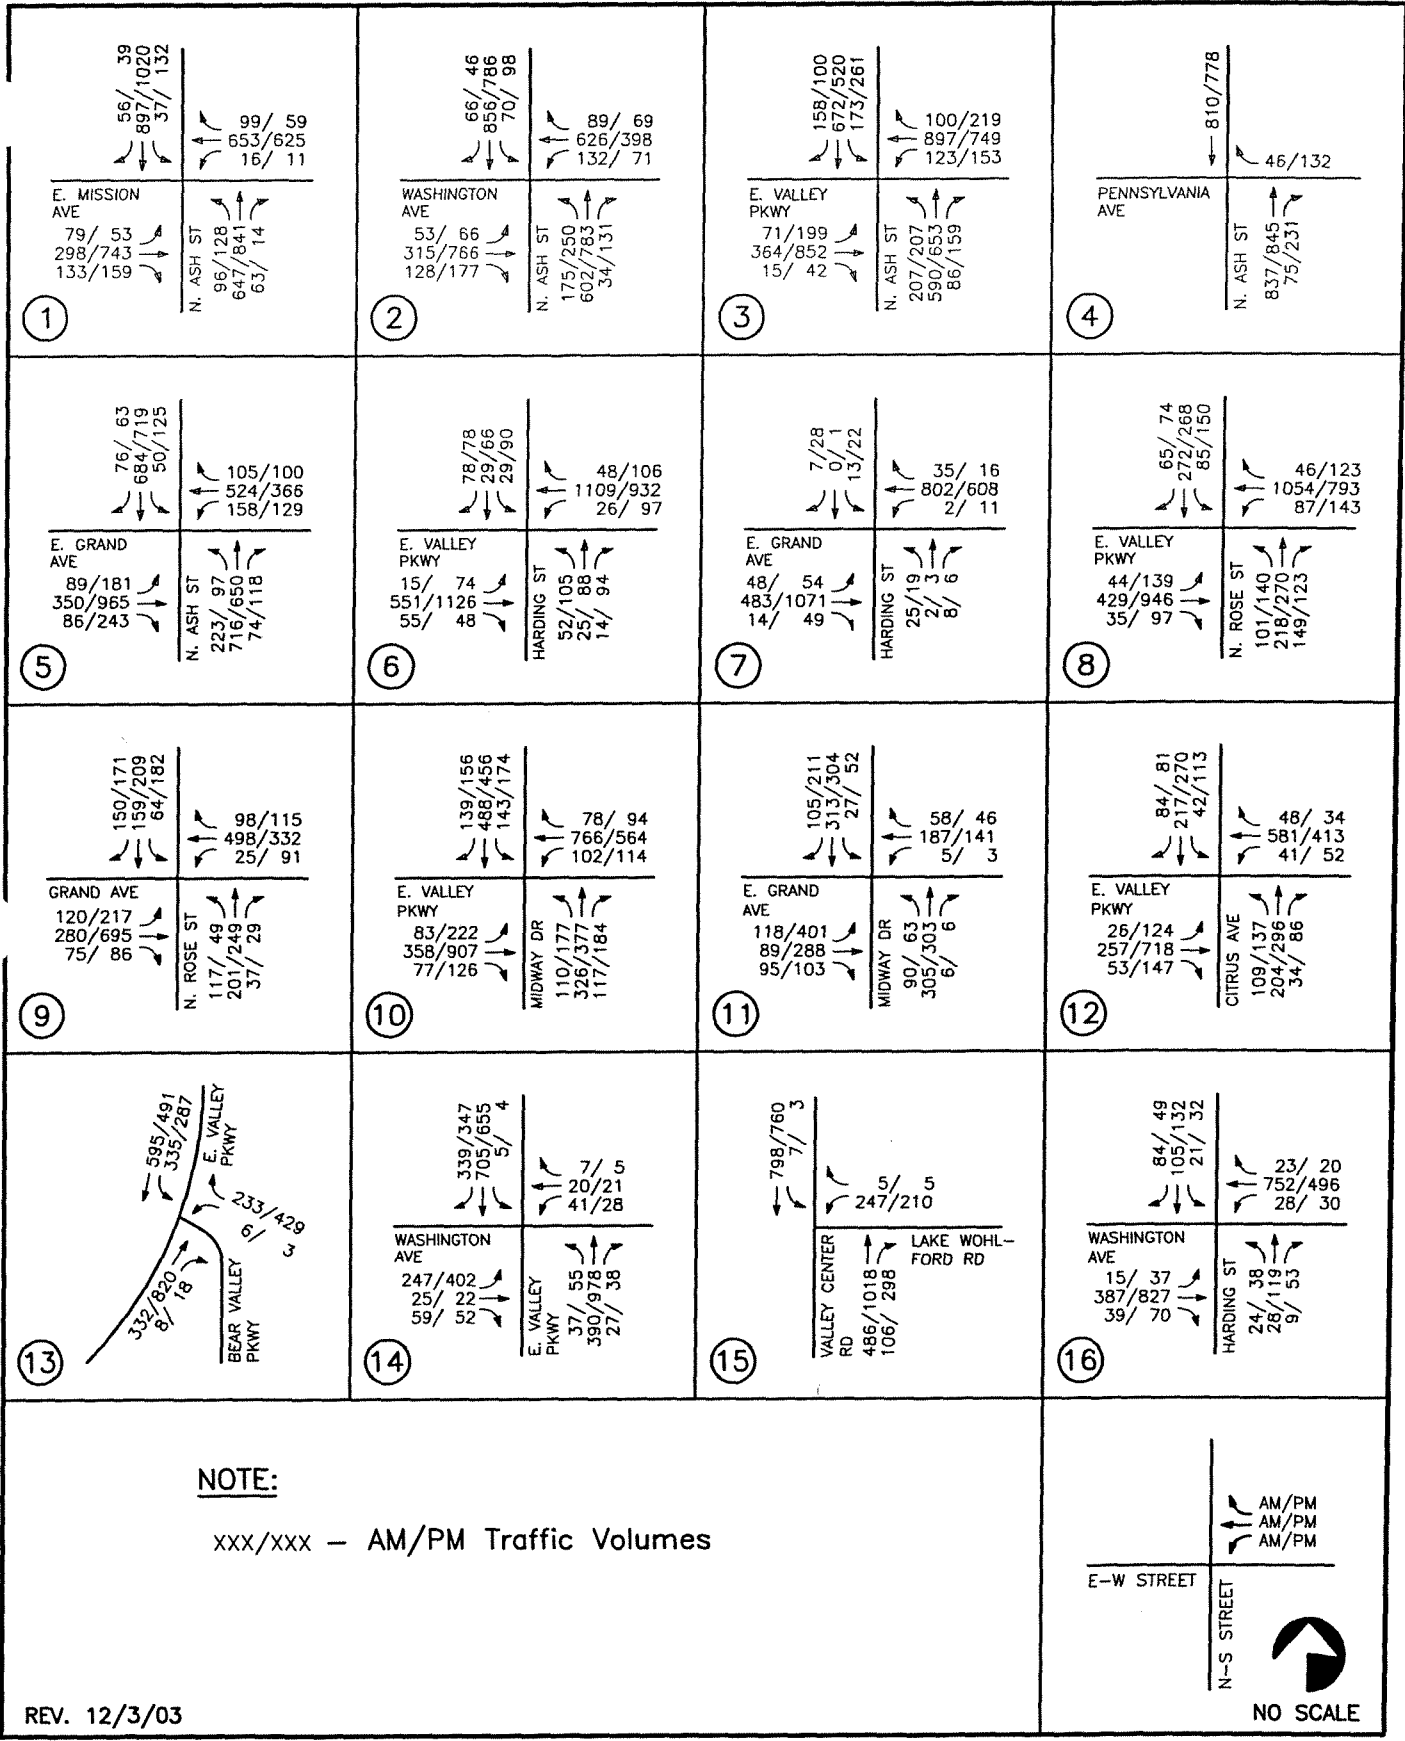
# Figure 6

EXISTING TRAFFIC VOLUMES  
AM/PM PEAK HOURS

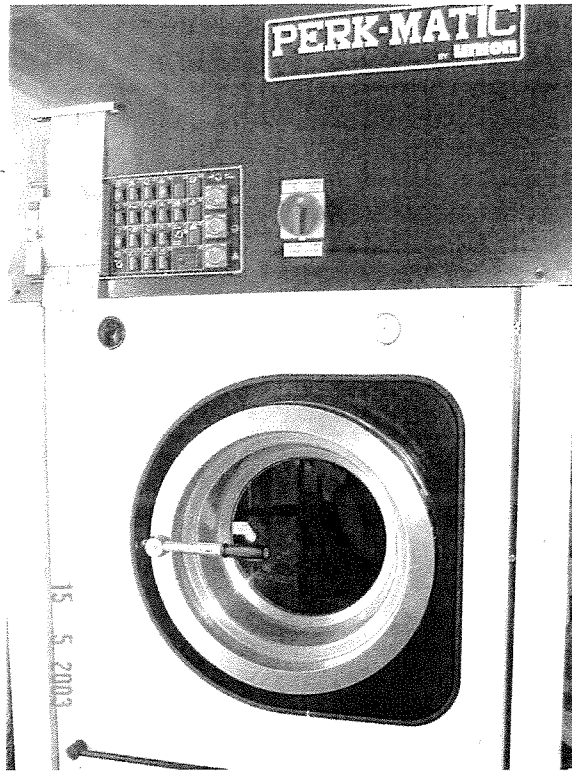
Lovett's One Hour Cleaners dry cleaning machine; no obvious signs of leaks or stains

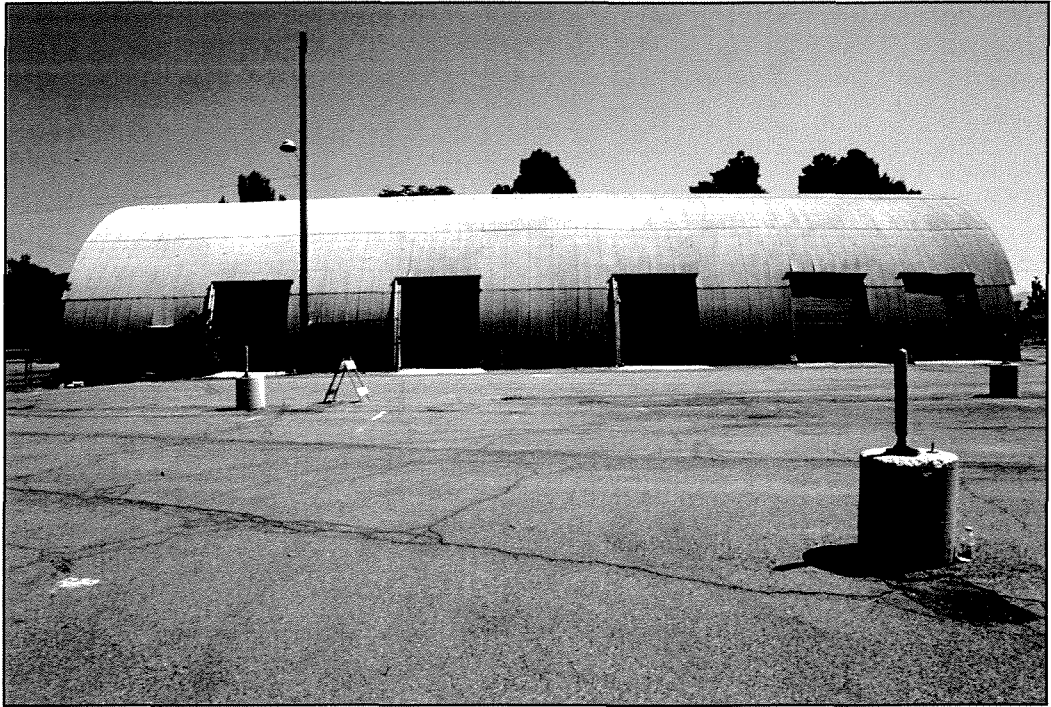
PHOTOGRAPH 1  
Looking at West and South Elevations of the  
Escondido Mutual Water District (EMWD) Shop/Warehouse
