BIOLOGICAL RESOURCES LETTER REPORT

Project Name: Harmony Grove Industrial Park

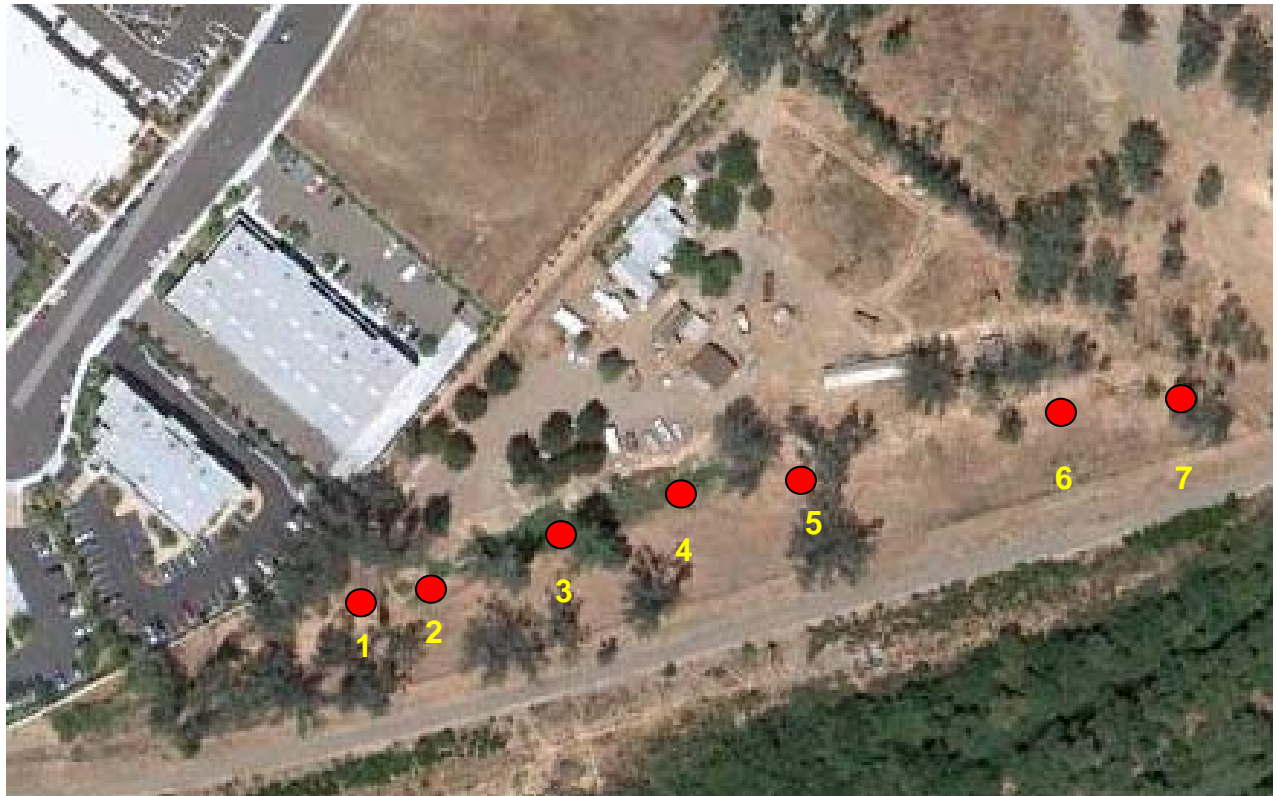
Figure 5. Locations of delineation sites and test pits.
